Access Compliance Report

Public Rights-of-Way

(Curb Ramps)

Intersection ID: 13408	Main Street: COMMONWEALTH_AV	Cross Street: THE_PLAZA	Location: E
ADA ID: 3F0EAFEB1690	Ramp Type: Directional1	Initial Pass/Fail: Fail	Overall Compliance: No
Severity Score: 1.25			
Codes/Mitigation Info/Possible Solution		Field Measurements/Component Compliance

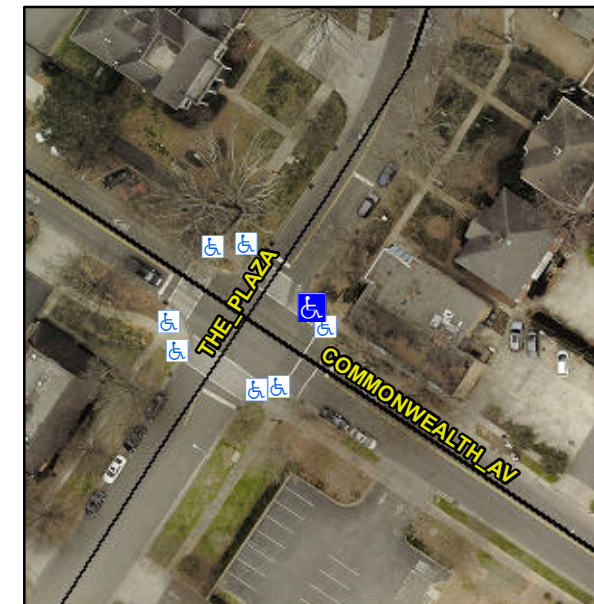
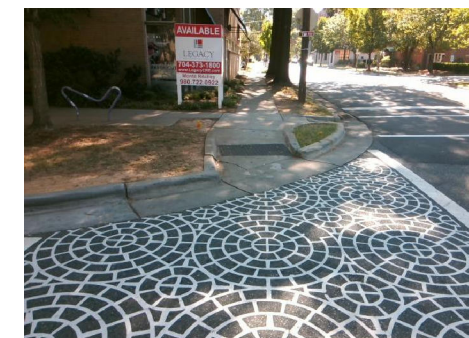
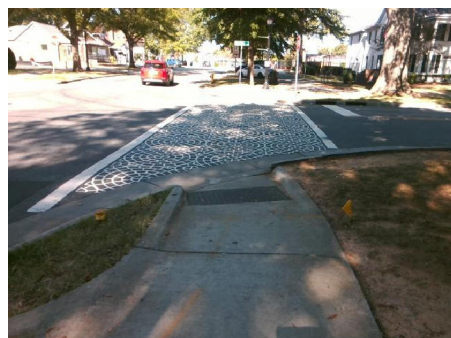
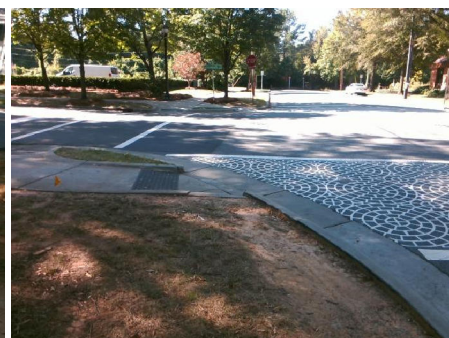
R304.5.3

Compliance	Description	Data	Compliance	Description	Data
N/A	Ramp Length (in)	65.5	N/A	Grade Break?	N/A
Yes	Ramp Width (in)	50.5	N/A	Grade Break Slope (%)	0.0
Yes	Ramp Slope (%)	7.5	N/A	Grade Break XSlope (%)	0.0
No	Ramp XSlope (%)	2.8			
N/A	Flare Type LT	N/A	N/A	Flare Type RT	N/A
N/A	Flare Slope LT (%)	N/A	N/A	Flare Slope RT (%)	0.0
N/A	Flare Traversable LT?	N/A	N/A	Flare Traversable RT?	N/A
N/A	Landing Length (in)	0.0	N/A	DWS Provided?	N/A
N/A	Landing Width (in)	0.0	N/A	DWS Contrast?	N/A
N/A	Landing Slope (%)	0.0	N/A	DWS Length (in)	N/A
N/A	Landing X Slope (%)	0.0	N/A	DWS Full Width?	N/A
N/A	Landing Curb? (Y/N)	N/A	N/A	DWS Offset LT (in)	N/A
N/A	Shared Landing?	N/A	N/A	DWS Offset RT (in)	N/A
N/A	Gutter Ponding?	0.0	N/A	Gutter Slope (%)	N/A
N/A	Gutter Lip Ht (in)	0.0	N/A	Gutter X Slope (%)	N/A
N/A	Painted X Walk1?	Yes		Road Slope (%)	1.3
	X Walk 1 Direction	To NW		Road X Slope (%)	0.3
	X Walk 1 Width (in)	125.0		Clear Space?	N/A

X Walk 1 Slope (%)	1.3	N/A	Clear Space to XWalk (in)	N/A
	X Walk 1 X Slope (%)	0.3	N/A	Storm Grate/Utility Hazard?	N/A
N/A	Ramp inside XWalk1?	Yes		Storm Grate/Utility Type	
N/A	Any Obstructions?	N/A			N/A
	Obstruction Type		Yes	Surface Condition? (G/P)	Good
			N/A	Curb Slope (%)	9.9

Remove & Replace Entire Ramp.

\$ 1600.00
