Access Compliance Report Public Rights-of-Way (Curb Ramps)

Intersection ID: N/A	Main Street: RIDGE_OAK_DR	Cross Street: OVERCUP_LN	Location: NW
ADA ID: 3F12C511B052	Ramp Type: Perp	Initial Pass/Fail: Fail	Overall Compliance: No Severity Score: 18.75

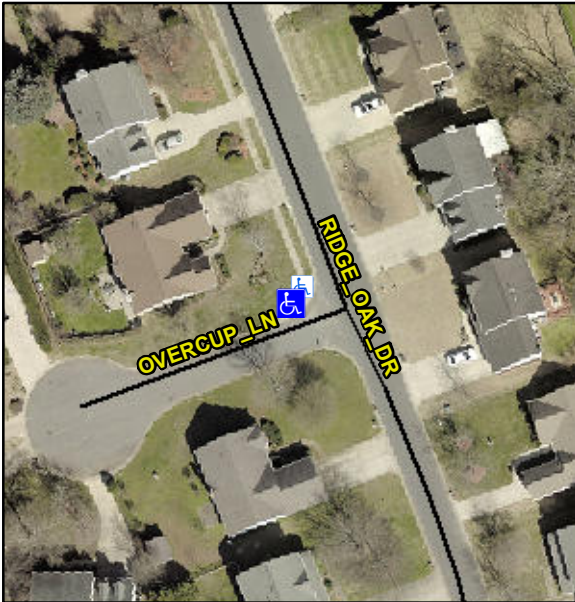
PROW/ADA:
R304.5.1, R304.5.3

Compliance	Description	Data	Compliance	Description	Data
N/A	Ramp Length (in)	95.0	Yes	Ramp Slope (%)	5.6
No	Ramp Width (in)	34.0	No	Ramp XSlope (%)	2.1
N/A	Flare Type LT	N/A	N/A	Flare Type RT	N/A
N/A	Flare Slope LT (%)	N/A	N/A	Flare Slope RT (%)	N/A
N/A	Flare Traversable LT?	N/A	N/A	Flare Traversable RT?	N/A
N/A	Landing Length (in)	N/A	N/A	DWS Provided?	N/A
N/A	Landing Width (in)	N/A	N/A	DWS Contrast?	N/A
N/A	Landing Slope (%)	N/A	N/A	DWS Length (in)	N/A
N/A	Landing X Slope (%)	N/A	N/A	DWS Full Width?	N/A
N/A	Landing Curb? (Y/N)	N/A	N/A	DWS Offset (in)	N/A
N/A	Shared Landing?	N/A			
N/A	Gutter Ponding?	N/A	N/A	Gutter Slope (%)	N/A
N/A	Gutter Lip Ht (in)	N/A	N/A	Gutter X Slope (%)	N/A
N/A	Painted X Walk1?	No	N/A	Painted X Walk2?	N/A
	X Walk 1 Direction	To S		X Walk 2 Direction	N/A
N/A	X Walk 1 Width (in)	N/A	N/A	X Walk 2 Width (in)	N/A
	X Walk 1 Slope (%)	0.6		X Walk 2 Slope (%)	N/A
	X Walk 1 X Slope (%)	0.3		X Walk 2 X Slope (%)	N/A

N/A	Ramp inside XWalk1?	N/A	N/A	Ramp inside XWalk2?	N/A
	Road Slope (%)	N/A	N/A	Clear Space?	N/A
	Road X Slope (%)	N/A	N/A	Clear Space to XWalk (in)	N/A
N/A	Any Obstructions?	N/A	N/A	Storm Grate/Utility Hazard?	N/A
	Obstruction Type			Storm Grate/Utility Type	
			N/A		N/A
			Yes	Surface Condition? (G/P)	Good

Possible Solutions:
Remove & Replace Entire Ramp.
