Access Compliance Report

Public Rights-of-Way

(Curb Ramps)

Intersection ID: 12937	Main Street: E_W_T_HARRIS_BV	Cross Street: HICKORY_GROVE_RD	Location: SW
ADA ID: 3F18A737E2C5	Ramp Type: Perp	Initial Pass/Fail: Fail	Overall Compliance: No
Codes/Mitigation Info/Possible Solution		Field Measurements/Component Compliance

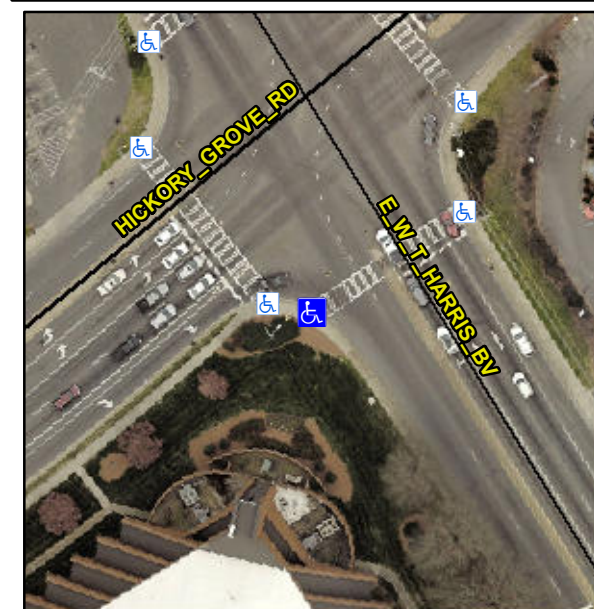
Not Found, R304.5.1, R304.2.2

Compliance	Description	Data	Compliance	Description	Data
N/A	Ramp Length (in)	25.0	No	Ramp Slope (%)	15.1
No	Ramp Width (in)	45.5	Yes	Ramp XSlope (%)	1.8
N/A	Flare Type LT	N/A	N/A	Flare Type RT	N/A
N/A	Flare Slope LT (%)	N/A	N/A	Flare Slope RT (%)	N/A
N/A	Flare Traversable LT?	N/A	N/A	Flare Traversable RT?	N/A
N/A	Landing Length (in)	N/A	N/A	DWS Provided?	N/A
N/A	Landing Width (in)	N/A	N/A	DWS Contrast?	N/A
N/A	Landing Slope (%)	N/A	N/A	DWS Length (in)	N/A
N/A	Landing X Slope (%)	N/A	N/A	DWS Full Width?	N/A
N/A	Landing Curb? (Y/N)	N/A	N/A	DWS Offset (in)	N/A
N/A	Shared Landing?	N/A			
N/A	Gutter Ponding?	N/A	N/A	Gutter Slope (%)	N/A
N/A	Gutter Lip Ht (in)	N/A	N/A	Gutter X Slope (%)	N/A
N/A	Painted X Walk1?	Yes	N/A	Painted X Walk2?	N/A
	X Walk 1 Direction	To E		X Walk 2 Direction	N/A
N/A	X Walk 1 Width (in)	115.0	N/A	X Walk 2 Width (in)	N/A
	X Walk 1 Slope (%)	1.6		X Walk 2 Slope (%)	N/A
	X Walk 1 X Slope (%)	1.2		X Walk 2 X Slope (%)	N/A

N/A	Ramp inside XWalk1?	Yes	N/A	Ramp inside XWalk2?	N/A
	Road Slope (%)	N/A	N/A	Clear Space?	N/A
	Road X Slope (%)	N/A	N/A	Clear Space to XWalk (in)	N/A
N/A	Any Obstructions?	N/A	N/A	Storm Grate/Utility Hazard?	N/A
	Obstruction Type			Storm Grate/Utility Type	
		N/A			N/A
			Yes	Surface Condition? (G/P)	Good

Possible Solutions:

Remove & Replace Entire Ramp.
