# Access Compliance Report

## Public Rights-of-Way

### (Curb Ramps)

Intersection ID: 43842	Main Street: BRADSTREET COMMONS WY	Cross Street: DELUCA DR	Location: SE
ADA ID: 3F20DEABEFD4	Ramp Type: PerpDiag	Initial Pass/Fail: Fail	Overall Compliance: No
Severity Score: 8.75			
Codes/Mitigation Info/Possible Solution		Field Measurements/Component Compliance

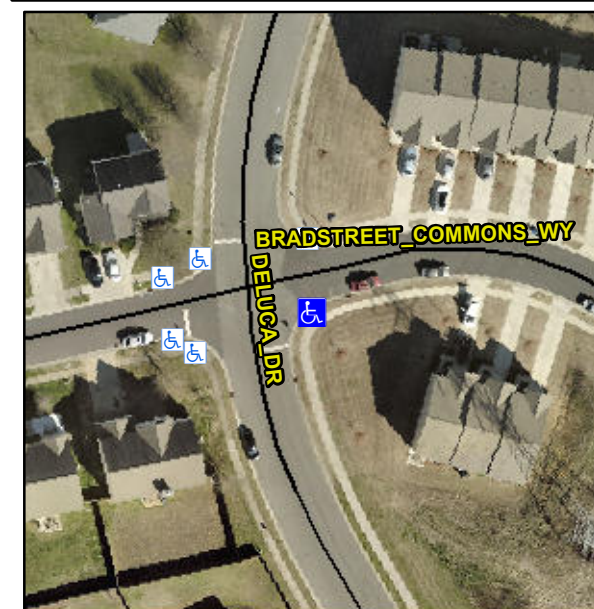
Compliance	Description	Data	Compliance	Description	Data
N/A	Ramp Length (in)	47.5	Yes	Ramp Slope (%)	5.5
No	Ramp Width (in)	47.0	Yes	Ramp XSlope (%)	0.7
N/A	Flare Type LT	N/A	N/A	Flare Type RT	N/A
N/A	Flare Slope LT (%)	N/A	N/A	Flare Slope RT (%)	N/A
N/A	Flare Traversable LT?	N/A	N/A	Flare Traversable RT?	N/A
N/A	Landing Length (in)	N/A	N/A	DWS Provided?	N/A
N/A	Landing Width (in)	N/A	N/A	DWS Contrast?	N/A
N/A	Landing Slope (%)	N/A	N/A	DWS Length (in)	N/A
N/A	Landing X Slope (%)	N/A	N/A	DWS Full Width?	N/A
N/A	Landing Curb? (Y/N)	N/A	N/A	DWS Offset (in)	N/A
N/A	Shared Landing?	N/A			
N/A	Gutter Ponding?	N/A	N/A	Gutter Slope (%)	N/A
N/A	Gutter Lip Ht (in)	N/A	N/A	Gutter X Slope (%)	N/A
N/A	Painted X Walk1?	No	N/A	Painted X Walk2?	No
	X Walk 1 Direction	To N		X Walk 2 Direction	To W
N/A	X Walk 1 Width (in)	N/A	N/A	X Walk 2 Width (in)	N/A
	X Walk 1 Slope (%)	2.7		X Walk 2 Slope (%)	1.3
	X Walk 1 X Slope (%)	1.8		X Walk 2 X Slope (%)	4.3

N/A	Ramp inside XWalk1?	N/A	N/A	Ramp inside XWalk2?	N/A
	Road Slope (%)	1.7	N/A	Clear Space?	N/A
	Road X Slope (%)	1.0	N/A	Clear Space to XWalk (in)	N/A
N/A	Any Obstructions?	N/A	N/A	Storm Grate/Utility Hazard?	N/A
	Obstruction Type			Storm Grate/Utility Type	
		N/A			N/A
		Yes		Surface Condition? (G/P)	Good

Possible Solutions:

**Remove & Replace Curb Ramp With Two New Directional Ramps or Equivalent.**

Total Cost: \$ 3200.00
