# Access Compliance Report

### (Curb Ramps)

| Intersection ID: 32231 | Main Street: CAMBRIDGE_GREEN_DR | Cross Street: OXFORD_COMMONS_DR | Location: E |
| ADA ID: 3F21D855579D | Ramp Type: Perp | Initial Pass/Fail: Fail | Overall Compliance: No |

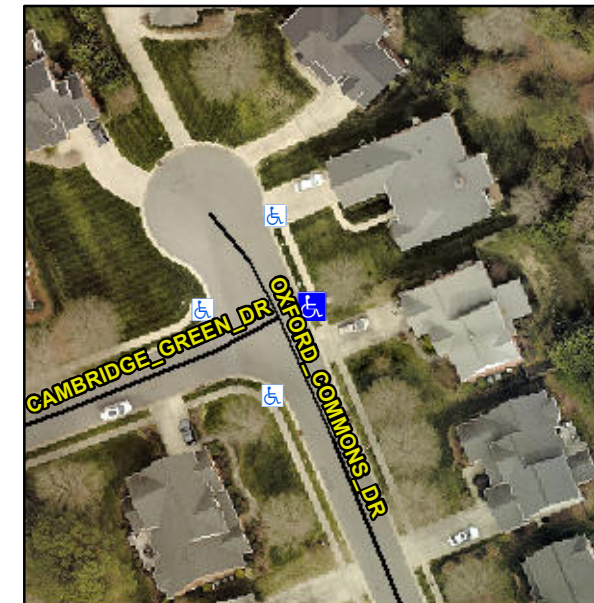
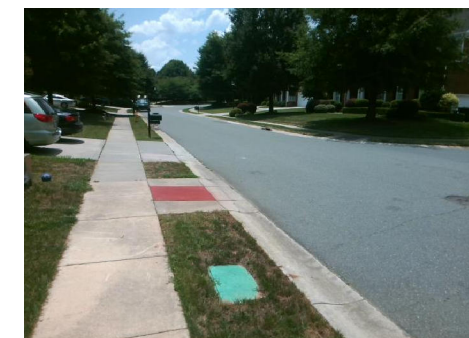
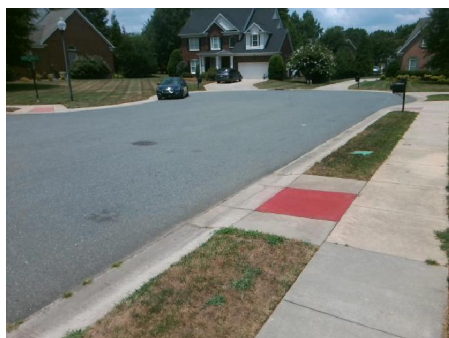
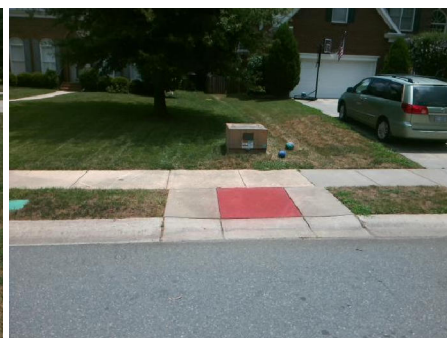
**Not Found, R304.5.1, R304.2.2**

| Compliance | Description | Data | Compliance | Description | Data |
|---|---|---|---|---|---|
| N/A | Ramp Length (in) | 48.0 | No | Ramp Slope (%) | 8.9 |
| No | Ramp Width (in) | 47.5 | Yes | Ramp XSlope (%) | 1.7 |

**Remove & Replace Entire Ramp.**

Total Cost: \$ 1850.00
