Access Compliance Report

Public Rights-of-Way

(Curb Ramps)

Intersection ID: 29723	Main Street: LANNIER FALLS LN	Cross Street: MEDOC MOUNTAIN DR	Location: W
ADA ID: 3F31C5C32BF7	Ramp Type: BlendTrans1	Initial Pass/Fail: Fail	Overall Compliance: No
Severity Score: 8.75			
Codes/Mitigation Info/Possible Solution		Field Measurements/Component Compliance

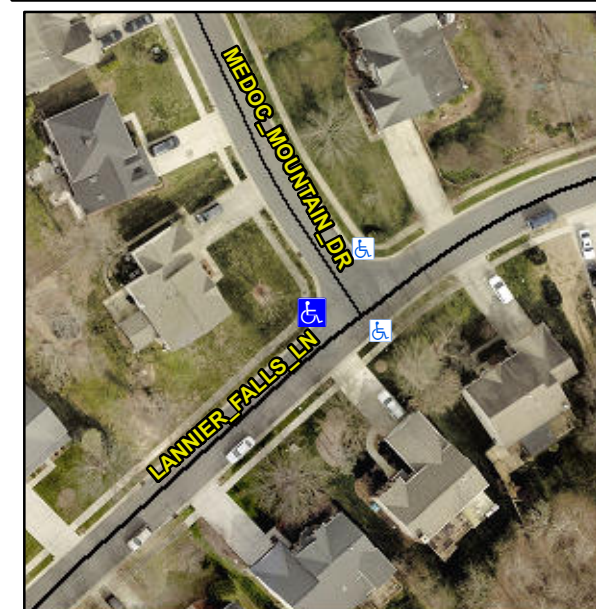
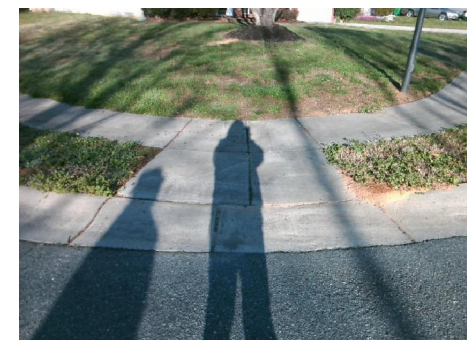
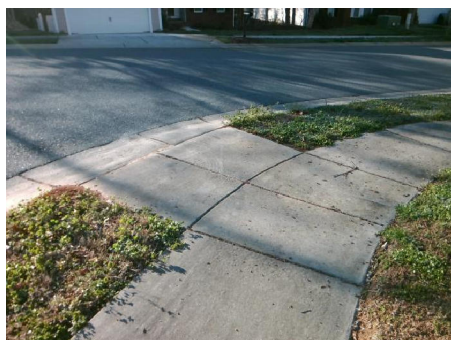
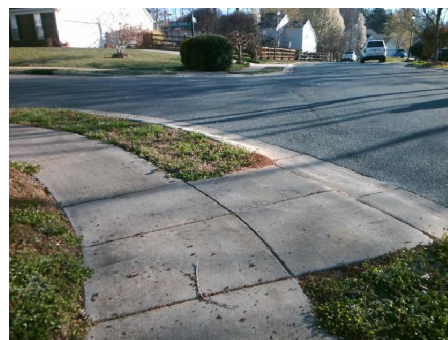
Not Found, R304.5.1

Compliance	Description	Data	Compliance	Description	Data
N/A	Ramp Length (in)	47.5	Yes	BlendTrans Slope (%)	2.1
No	Ramp Width (in)	40.0	Yes	BlendTrans XSlope (%)	1.3
N/A	Flare Type LT	N/A	N/A	Flare Type RT	N/A
N/A	Flare Slope LT (%)	N/A	N/A	Flare Slope RT (%)	N/A
N/A	Flare Traversable LT?	N/A	N/A	Flare Traversable RT?	N/A
N/A	Landing Length (in)	N/A	N/A	DWS Provided?	N/A
N/A	Landing Width (in)	N/A	N/A	DWS Contrast?	N/A
N/A	Landing Slope (%)	N/A	N/A	DWS Length (in)	N/A
N/A	Landing X Slope (%)	N/A	N/A	DWS Full Width?	N/A
N/A	Landing Curb? (Y/N)	N/A	N/A	DWS Offset (in)	N/A
N/A	Shared Landing?	N/A			
N/A	Gutter Ponding?	N/A	N/A	Gutter Slope (%)	N/A
N/A	Gutter Lip Ht (in)	N/A	N/A	Gutter X Slope (%)	N/A
N/A	Painted X Walk1?	No	N/A	Painted X Walk2?	No
	X Walk 1 Direction	To SE		X Walk 2 Direction	To NE
	X Walk 1 Width (in)	N/A		X Walk 2 Width (in)	N/A
	X Walk 1 Slope (%)	3.2		X Walk 2 Slope (%)	6.8
	X Walk 1 X Slope (%)	4.7		X Walk 2 X Slope (%)	0.3

N/A	Ramp inside XWalk1?	N/A	N/A	Ramp inside XWalk2?	N/A
	Road Slope (%)	3.1		Clear Space?	N/A
	Road X Slope (%)	6.5	N/A	Clear Space to XWalk (in)	N/A
N/A	Any Obstructions?	N/A	N/A	Storm Grate/Utility Hazard?	N/A
	Obstruction Type			Storm Grate/Utility Type	
		N/A			N/A
			Yes	Surface Condition? (G/P)	Good
			No	Curb Slope (%)	6.1

Remove & Replace Curb Ramp With Two New Directional Ramps or Equivalent.

Total Cost: \$ 3200.00
