## Access Compliance Report Public Rights-of-Way (Curb Ramps)

Intersection ID: 9343 Main Street: CAMPUS\_ST Cross Street: SANDERS\_AV Location: NW

ADA ID: 3F3724E49BBB Ramp Type: Perp Initial Pass/Fail: Fail Overall Compliance: No Severity Score: 13.75

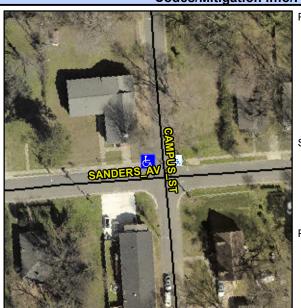
N/A	Ramp Length (in)	52.0	No	Ramp Slope (%)	11.0
Yes	Ramp Width (in)	113.0	No	Ramp XSlope (%)	4.3
N/A	Flare Type LT	N/A	N/A	Flare Type RT	N/A
N/A	Flare Slope LT (%)	N/A	N/A	Flare Slope RT (%)	N/A
N/A	Flare Traversable LT?	N/A	N/A	Flare Traversable RT?	N/A
N/A	Landing Length (in)	N/A	N/A	DWS Provided?	N/A
N/A	Landing Width (in)	N/A	N/A	DWS Contrast?	N/A
N/A	Landing Slope (%)	N/A	N/A	DWS Length (in)	N/A
N/A	Landing X Slope (%)	N/A	N/A	DWS Full Width?	N/A
N/A	Landing Curb? (Y/N)	N/A	N/A	DWS Offset (in)	N/A
N/A	Shared Landing?	N/A			
N/A	Gutter Ponding?	N/A	N/A	Gutter Slope (%)	N/A
N/A	Gutter Lip Ht (in)	N/A	N/A	Gutter X Slope (%)	N/A
N/A	Painted X Walk1?	No	N/A	Painted X Walk2?	N/A
	X Walk 1 Direction	To E		X Walk 2 Direction	N/A
N/A	X Walk 1 Width (in)	N/A	N/A	X Walk 2 Width (in)	N/A
	X Walk 1 Slope (%)	3.6		X Walk 2 Slope (%)	N/A
	X Walk 1 X Slope (%)	1.5		X Walk 2 X Slope (%)	N/A
N/A	Ramp inside XWalk1?	N/A	N/A	Ramp inside XWalk2?	N/A

Road Slope (%)	N/A	N/A	Clear Space?	N/A
	Road X Slope (%)	N/A	N/A	Clear Space to XWalk (in)	N/A
N/A	Any Obstructions?	N/A	N/A	Storm Grate/Utility Hazard?	N/A
	Obstruction Type			Storm Grate/Utility Type	
		N/A			N/A
			Yes	Surface Condition? (G/P)	Good

Possible Solutions:	Compl	iance Description
Remove & Replace Entire Ramp.	N/A Ramp Length (in)	
· ·	Yes	Ramp Width (in)
	N/A	Flare Type LT
	N/A	Flare Slope LT (%)
	N/A	Flare Traversable LT
	N/A	Landing Length (in)
Surveyor Notes:	N/A	Landing Width (in)
N/A	N/A	Landing Slope (%)
	N/A	Landing X Slope (%)
	N/A	Landing Curb? (Y/N)
	N/A	Shared Landing?
PROW/ADA:	N/A	Gutter Ponding?
Not Found, R304.2.2, R304.5.3	N/A	Gutter Lip Ht (in)
, ,	N/A	Painted X Walk1?
		X Walk 1 Direction
	N/A	X Walk 1 Width (in)
		X Walk 1 Slope (%)
		X Walk 1 X Slope (%
	N/Δ	Ramn inside XWalk1
