Access Compliance Report

Public Rights-of-Way

(Curb Ramps)

Intersection ID: 18174	Main Street: EAGLEWOOD_AV	Cross Street: MONROE_RD	Location: SW
ADA ID: 3F3C4679D82B	Ramp Type: PerpDiag	Initial Pass/Fail: Fail	Overall Compliance: No
		Severity Score: 12.5

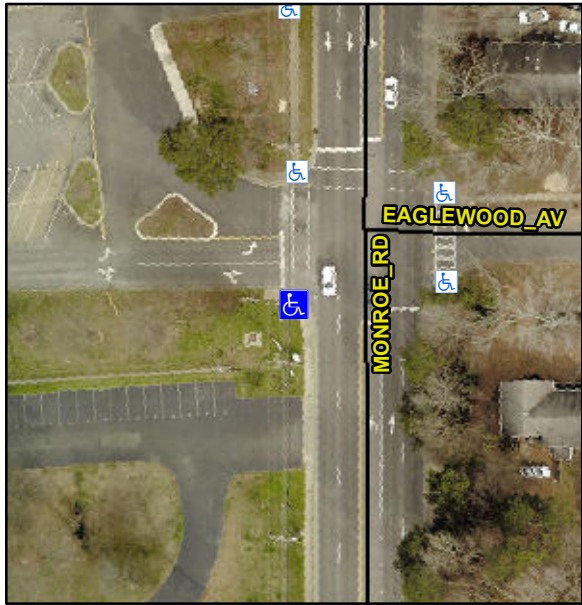
Compliance	Description	Data	Compliance	Description	Data
N/A	Ramp Length (in)	60.0	No	Ramp Slope (%)	9.7
Yes	Ramp Width (in)	48.0	Yes	Ramp XSlope (%)	0.7
N/A	Flare Type LT	N/A	N/A	Flare Type RT	N/A
N/A	Flare Slope LT (%)	N/A	N/A	Flare Slope RT (%)	N/A
N/A	Flare Traversable LT?	N/A	N/A	Flare Traversable RT?	N/A
N/A	Landing Length (in)	N/A	N/A	DWS Provided?	N/A
N/A	Landing Width (in)	N/A	N/A	DWS Contrast?	N/A
N/A	Landing Slope (%)	N/A	N/A	DWS Length (in)	N/A
N/A	Landing X Slope (%)	N/A	N/A	DWS Full Width?	N/A
N/A	Landing Curb? (Y/N)	N/A	N/A	DWS Offset (in)	N/A
N/A	Shared Landing?	N/A			
N/A	Gutter Ponding?	N/A	N/A	Gutter Slope (%)	N/A
N/A	Gutter Lip Ht (in)	N/A	N/A	Gutter X Slope (%)	N/A
N/A	Painted X Walk1?	No	N/A	Painted X Walk2?	Yes
	X Walk 1 Direction	To E		X Walk 2 Direction	To N
N/A	X Walk 1 Width (in)	N/A	N/A	X Walk 2 Width (in)	89.0
	X Walk 1 Slope (%)	1.3		X Walk 2 Slope (%)	1.0
	X Walk 1 X Slope (%)	0.2		X Walk 2 X Slope (%)	0.8

N/A	Ramp inside XWalk1?	N/A	N/A	Ramp inside XWalk2?	Yes
	Road Slope (%)	0.2	N/A	Clear Space?	N/A
	Road X Slope (%)	0.9	N/A	Clear Space to XWalk (in)	N/A
N/A	Any Obstructions?	N/A	N/A	Storm Grate/Utility Hazard?	N/A
	Obstruction Type			Storm Grate/Utility Type	
		N/A			N/A
			Yes	Surface Condition? (G/P)	Good

Possible Solutions:							
	Remove & Replace Curb Ramp With Two New Directional Ramps or Equivalent.		N/A	Ramp Length (in)	60.0	No	Ramp Slope (%)	9.7
			Yes	Ramp Width (in)	48.0	Yes	Ramp XSlope (%)	0.7
			N/A	Flare Type LT	N/A	N/A	Flare Type RT	N/A
			N/A	Flare Slope LT (%)	N/A	N/A	Flare Slope RT (%)	N/A
			N/A	Flare Traversable LT?	N/A	N/A	Flare Traversable RT?	N/A
			N/A	Landing Length (in)	N/A	N/A	DWS Provided?	N/A
			N/A	Landing Width (in)	N/A	N/A	DWS Contrast?	N/A
			N/A	Landing Slope (%)	N/A	N/A	DWS Length (in)	N/A
			N/A	Landing X Slope (%)	N/A	N/A	DWS Full Width?	N/A
Surveyor Notes:		N/A						
PROW/ADA:		Not Found, R304.2.2						
Street 1 Name		MONROE RD						
Stop Condition-Street 2		Signal						
Street 2 Name		EAGLEWOOD AV						
Stop Condition-Street 1		Signal						
Total Cost:		\$ 3200.00
