Access Compliance Report Public Rights-of-Way (Curb Ramps)

Intersection ID: 45756 Main Street: CHRISTENBURY_RD Cross Street: GRANDEUR_RD Location: NW

ADA ID: 3F4AC1FFA312 Ramp Type: PerpDiag Initial Pass/Fail: Fail Overall Compliance: No Severity Score: 33.75

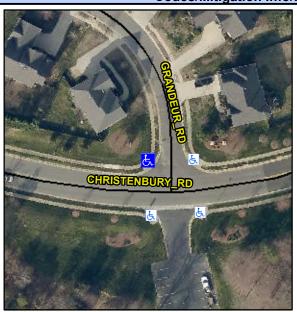
Not Found, R304.5.1, R304.2.2

9	Compliance	iance Description		Compliance Description		Description	Data
N	N/A Ram	np Length (in)	47.0	No	Ramp	Slope (%)	18.8
N	No Ram	np Width (in)	41.0	Yes	Ramp	XSlope (%)	1.4
N	\/A Flar	e Type LT	N/A	N/A	Flare	Type RT	N/A
N	N/A Flar	e Slope LT (%)	N/A	N/A	Flare	Slope RT (%)	N/A
N	N/A Flar	e Traversable LT?	N/A	N/A	Flare	Traversable RT?	N/A
N	N/A Land	ding Length (in)	N/A	N/A	DWS	Provided?	N/A
N	N/A Land	ding Width (in)	N/A	N/A	DWS	Contrast?	N/A
N	N/A Land	ding Slope (%)	N/A	N/A	DWS	Length (in)	N/A
N	N/A Land	ding X Slope (%)	N/A	N/A	DWS	Full Width?	N/A
N	N/A Land	ding Curb? (Y/N)	N/A	N/A	DWS	Offset (in)	N/A
N	N/A Sha	red Landing?	N/A				
N	N/A Gutt	ter Ponding?	N/A	N/A	Gutte	r Slope (%)	N/A
N	I/A Gutt	er Lip Ht (in)	N/A	N/A	Gutte	r X Slope (%)	N/A
N	N/A Pain	ited X Walk1?	No	N/A	Painte	ed X Walk2?	No
	ΧW	alk 1 Direction	To S		X Wa	lk 2 Direction	To E
N	N/A XW	alk 1 Width (in)	N/A	N/A	X Wa	lk 2 Width (in)	N/A

ΧW	alk 1 Slope (%)	2.4		X Wa	lk 2 Slope (%)	2.0
	ΧW	alk 1 X Slope (%)	1.0		X Wa	lk 2 X Slope (%)	6.2
N	N/A Ram	np inside XWalk1?	N/A	N/A	Ramp	inside XWalk2?	N/A
	Roa	d Slope (%)	2.8	N/A	Clear	Space?	N/A
	Roa	d X Slope (%)	3.3	N/A	Clear	Space to XWalk (in)	N/A
N	N/A Any	Obstructions?	N/A	N/A	Storm	Grate/Utility Hazard?	N/A
	Obs	truction Type			Storm	Grate/Utility Type	
			N/A				N/A
				Yes	Surfa	ce Condition? (G/P)	Good

Remove & Replace Curb Ramp With Two New Directional Ramps or Equivalent.
