# Access Compliance Report

## Public Rights-of-Way

### (Curb Ramps)

Intersection ID: 3062	Main Street: LOGANVILLE_DR	Cross Street: PROSPERITY_CHURCH_RD	Location:	E
ADA ID: 3F4FC356F8B9	Ramp Type: Directional1	Initial Pass/Fail: Pass	Overall Compliance: No	Severity Score: 0

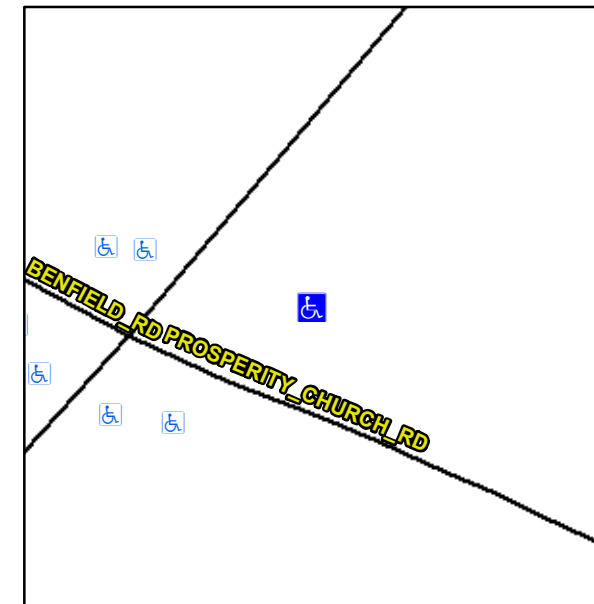
Surveyor Notes:

**VEGETATION OVERGROWTH**

Compliance	Description	Data	Compliance	Description	Data
N/A	Ramp Length (in)	138.0	No	Grade Break?	No
Yes	Ramp Width (in)	61.5	N/A	Grade Break Slope (%)	4.5
Yes	Ramp Slope (%)	5.4	N/A	Grade Break XSlope (%)	2.0
Yes	Ramp XSlope (%)	0.3			
Yes	Flare Type LT	N/A	Yes	Flare Type RT	N/A
N/A	Flare Slope LT (%)	N/A	N/A	Flare Slope RT (%)	N/A
N/A	Flare Traversable LT?	No	N/A	Flare Traversable RT?	No
Yes	Landing Length (in)	54.0	Yes	DWS Provided?	Yes
Yes	Landing Width (in)	69.0	Yes	DWS Contrast?	Yes
No	Landing Slope (%)	4.9	Yes	DWS Length (in)	24.0
Yes	Landing X Slope (%)	0.0	Yes	DWS Full Width?	Yes
N/A	Landing Curb? (Y/N)	N/A	No	DWS Offset LT (in)	62.0
N/A	Shared Landing?	No	Yes	DWS Offset RT (in)	2.0
Yes	Gutter Ponding?	No	Yes	Gutter Slope (%)	0.1
Yes	Gutter Lip Ht (in)	0.0	Yes	Gutter X Slope (%)	1.8
N/A	Painted X Walk1?	Yes		Road Slope (%)	3.4
	X Walk 1 Direction	To W		Road X Slope (%)	1.2
	X Walk 1 Width (in)	117.5		Clear Space?	Yes

X Walk 1 Slope (%)	3.4	N/A	Clear Space to XWalk (in)	N/A
	X Walk 1 X Slope (%)	1.2	Yes	Storm Grate/Utility Hazard?	No
Yes	Ramp inside XWalk1?	Yes		Storm Grate/Utility Type	
Yes	Any Obstructions?	No			N/A
	Obstruction Type		Yes	Surface Condition? (G/P)	Good
			N/A	Curb Slope (%)	14.3

Possible Solutions:

**Remove & Replace Entire Ramp.**
