Access Compliance Report

Public Rights-of-Way

(Curb Ramps)

Intersection ID: 5978	Main Street: CONIFER_CR	Cross Street: MAYHURST_CT	Location: W
ADA ID: 3F61D39F2F1E	Ramp Type: Perp	Initial Pass/Fail: Fail	Overall Compliance: No
Severity Score: 13.75			
Codes/Mitigation Info/Possible Solution		Field Measurements/Component Compliance

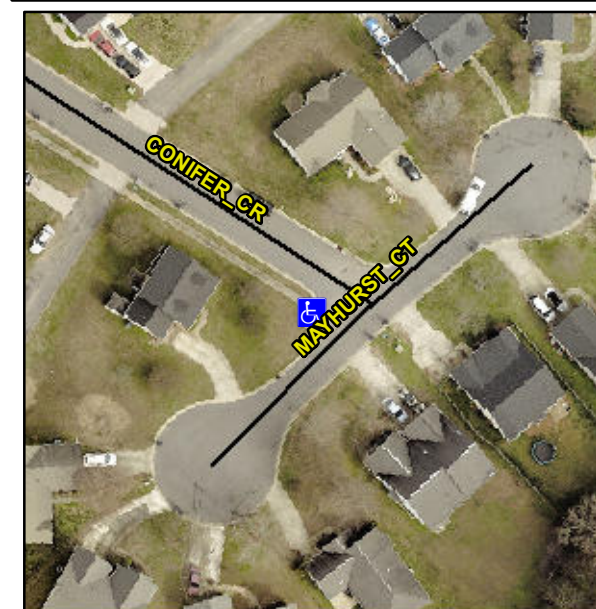
Not Found, R304.2.2, R304.5.3

Compliance	Description	Data	Compliance	Description	Data
N/A	Ramp Length (in)	48.0	No	Ramp Slope (%)	9.2
Yes	Ramp Width (in)	64.0	No	Ramp XSlope (%)	2.1
N/A	Flare Type LT	N/A	N/A	Flare Type RT	N/A
N/A	Flare Slope LT (%)	N/A	N/A	Flare Slope RT (%)	N/A
N/A	Flare Traversable LT?	N/A	N/A	Flare Traversable RT?	N/A
N/A	Landing Length (in)	N/A	N/A	DWS Provided?	N/A
N/A	Landing Width (in)	N/A	N/A	DWS Contrast?	N/A
N/A	Landing Slope (%)	N/A	N/A	DWS Length (in)	N/A
N/A	Landing X Slope (%)	N/A	N/A	DWS Full Width?	N/A
N/A	Landing Curb? (Y/N)	N/A	N/A	DWS Offset (in)	N/A
N/A	Shared Landing?	N/A			
N/A	Gutter Ponding?	N/A	N/A	Gutter Slope (%)	N/A
N/A	Gutter Lip Ht (in)	N/A	N/A	Gutter X Slope (%)	N/A
N/A	Painted X Walk1?	No	N/A	Painted X Walk2?	N/A
	X Walk 1 Direction	To NE		X Walk 2 Direction	N/A
N/A	X Walk 1 Width (in)	N/A	N/A	X Walk 2 Width (in)	N/A
	X Walk 1 Slope (%)	1.2		X Walk 2 Slope (%)	N/A
	X Walk 1 X Slope (%)	0.7		X Walk 2 X Slope (%)	N/A

N/A	Ramp inside XWalk1?	N/A	N/A	Ramp inside XWalk2?	N/A
	Road Slope (%)	N/A	N/A	Clear Space?	N/A
	Road X Slope (%)	N/A	N/A	Clear Space to XWalk (in)	N/A
N/A	Any Obstructions?	N/A	N/A	Storm Grate/Utility Hazard?	N/A
	Obstruction Type			Storm Grate/Utility Type	
		N/A			N/A
		Yes		Surface Condition? (G/P)	Good

Possible Solutions:

Remove & Replace Entire Ramp.
