Access Compliance Report

Public Rights-of-Way (Curb Ramps)

Intersection ID: N/A	Main Street: COPPER_WY	Cross Street: N/A	Location: SE
ADA ID: 3F7196B030DE	Ramp Type: PerpDiag	Initial Pass/Fail: Fail	Overall Compliance: No
		Severity Score: 12.5

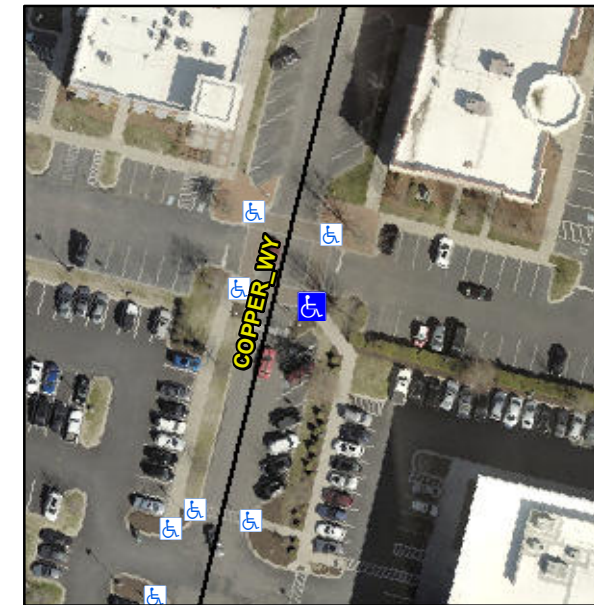
Not Found, R304.2.2

Compliance	Description	Data	Compliance	Description	Data
N/A	Ramp Length (in)	63.0	No	Ramp Slope (%)	9.8
Yes	Ramp Width (in)	48.0	Yes	Ramp XSlope (%)	2.0
N/A	Flare Type LT	N/A	N/A	Flare Type RT	N/A
N/A	Flare Slope LT (%)	N/A	N/A	Flare Slope RT (%)	N/A
N/A	Flare Traversable LT?	N/A	N/A	Flare Traversable RT?	N/A
N/A	Landing Length (in)	N/A	N/A	DWS Provided?	N/A
N/A	Landing Width (in)	N/A	N/A	DWS Contrast?	N/A
N/A	Landing Slope (%)	N/A	N/A	DWS Length (in)	N/A
N/A	Landing X Slope (%)	N/A	N/A	DWS Full Width?	N/A
N/A	Landing Curb? (Y/N)	N/A	N/A	DWS Offset (in)	N/A
N/A	Shared Landing?	N/A			
N/A	Gutter Ponding?	N/A	N/A	Gutter Slope (%)	N/A
N/A	Gutter Lip Ht (in)	N/A	N/A	Gutter X Slope (%)	N/A
N/A	Painted X Walk1?	Yes	N/A	Painted X Walk2?	Yes
	X Walk 1 Direction	To NE		X Walk 2 Direction	To NW
N/A	X Walk 1 Width (in)	108.0	N/A	X Walk 2 Width (in)	101.0
	X Walk 1 Slope (%)	0.4		X Walk 2 Slope (%)	0.8
	X Walk 1 X Slope (%)	1.2		X Walk 2 X Slope (%)	1.3

N/A	Ramp inside XWalk1?	Yes	N/A	Ramp inside XWalk2?	Yes
	Road Slope (%)	1.5	N/A	Clear Space?	N/A
	Road X Slope (%)	0.9	N/A	Clear Space to XWalk (in)	N/A
N/A	Any Obstructions?	N/A	N/A	Storm Grate/Utility Hazard?	N/A
	Obstruction Type			Storm Grate/Utility Type	
		N/A			N/A
		Yes		Surface Condition? (G/P)	Good

Remove & Replace Curb Ramp With Two New Directional Ramps or Equivalent.

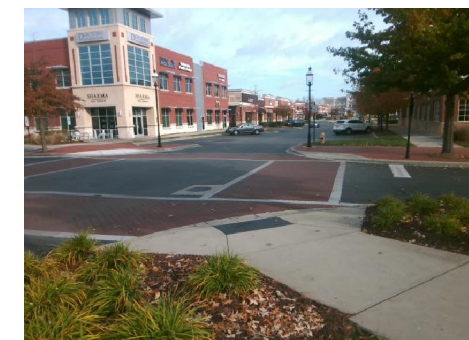
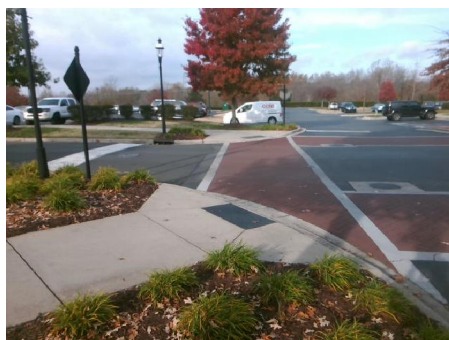
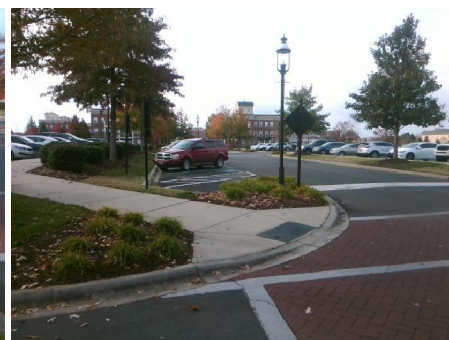
Street 1 Name **ENTRANCE**
 Stop Condition-Street 2 **StopSign**
 Street 2 Name **COPPER WY**
 Stop Condition-Street 1 **None**
