Access Compliance Report Public Rights-of-Way (Curb Ramps)

Intersection ID: 21239 Main Street: CAMBRIDGE BELTWAY DR **Cross Street: S TRYON ST** Location: SW

ADA ID: 3F7FBCB7104B Ramp Type: PerpDiag Initial Pass/Fail: Fail **Overall Compliance: No** Severity Score: 48.75

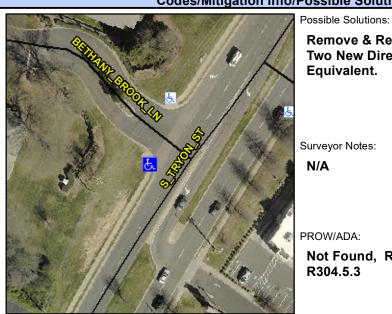
Not Found, R304.5.1, R304.2.2,

R304.5.3

Compliance Description		Data	Compliance Description		Data
N/A	Ramp Length (in)	87.0	No	Ramp Slope (%)	9.2
No	Ramp Width (in)	30.0	No	Ramp XSlope (%)	4.3
N/A	Flare Type LT	N/A	N/A	Flare Type RT	N/A
N/A	Flare Slope LT (%)	N/A	N/A	Flare Slope RT (%)	N/A
N/A	Flare Traversable LT?	N/A	N/A	Flare Traversable RT?	N/A
N/A	Landing Length (in)	N/A	N/A	DWS Provided?	N/A
N/A	Landing Width (in)	N/A	N/A	DWS Contrast?	N/A
N/A	Landing Slope (%)	N/A	N/A	DWS Length (in)	N/A
N/A	Landing X Slope (%)	N/A	N/A	DWS Full Width?	N/A
N/A	Landing Curb? (Y/N)	N/A	N/A	DWS Offset (in)	N/A
N/A	Shared Landing?	N/A			
N/A	Gutter Ponding?	N/A	N/A	Gutter Slope (%)	N/A
N/A	Gutter Lip Ht (in)	N/A	N/A	Gutter X Slope (%)	N/A
N/A	Painted X Walk1?	No	N/A	Painted X Walk2?	No
	X Walk 1 Direction	To SE		X Walk 2 Direction	To NE
N/A	X Walk 1 Width (in)	N/A	N/A	X Walk 2 Width (in)	N/A
	X Walk 1 Slope (%)	0.8		X Walk 2 Slope (%)	2.7
	X Walk 1 X Slope (%)	0.9		X Walk 2 X Slope (%)	0.8

S TRYON ST None **CAMBRIDGE BELTWAY DR** StopSign Remove & Replace Curb Ramp With **Two New Directional Ramps or** Equivalent.
