# Access Compliance Report

## Public Rights-of-Way

### (Curb Ramps)

Intersection ID: 10468	Main Street: E_35TH_ST	Cross Street: WHITING_AV	Location: SE
ADA ID: 3F86AC260468	Ramp Type: Perp	Initial Pass/Fail: Fail	Overall Compliance: No
Severity Score: 8.75			
Codes/Mitigation Info/Possible Solution		Field Measurements/Component Compliance

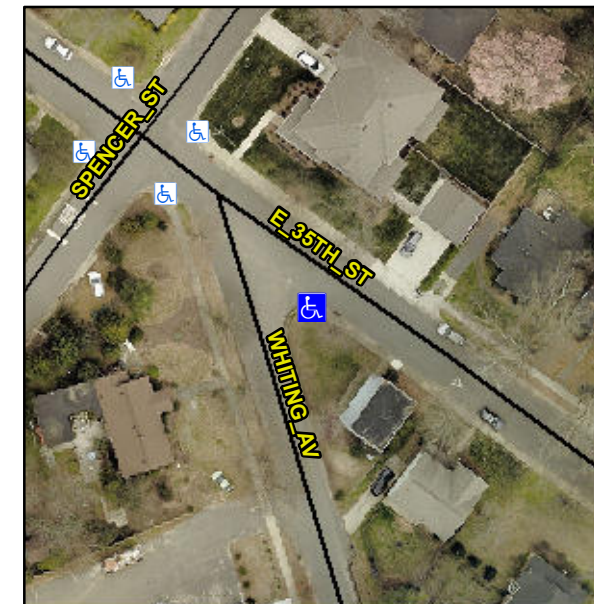
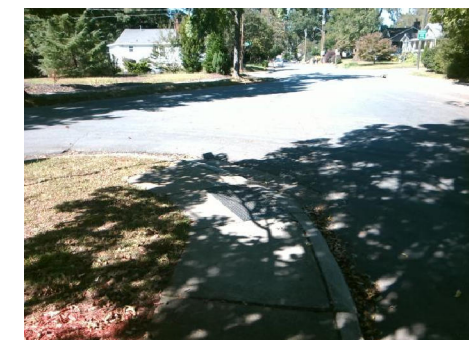
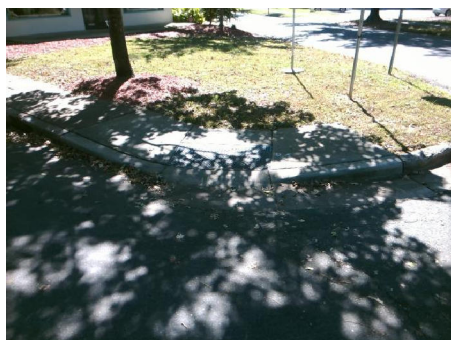
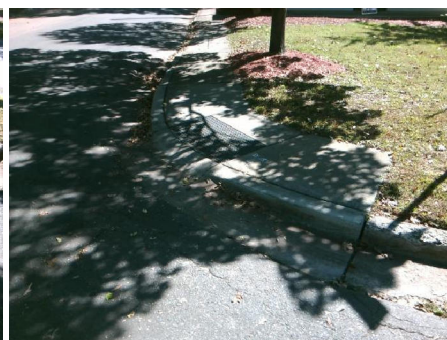
**Not Found, R304.5.1**

Compliance	Description	Data	Compliance	Description	Data
N/A	Ramp Length (in)	49.0	Yes	Ramp Slope (%)	6.8
No	Ramp Width (in)	46.0	Yes	Ramp XSlope (%)	1.7
N/A	Flare Type LT	N/A	N/A	Flare Type RT	N/A
N/A	Flare Slope LT (%)	N/A	N/A	Flare Slope RT (%)	N/A
N/A	Flare Traversable LT?	N/A	N/A	Flare Traversable RT?	N/A
N/A	Landing Length (in)	N/A	N/A	DWS Provided?	N/A
N/A	Landing Width (in)	N/A	N/A	DWS Contrast?	N/A
N/A	Landing Slope (%)	N/A	N/A	DWS Length (in)	N/A
N/A	Landing X Slope (%)	N/A	N/A	DWS Full Width?	N/A
N/A	Landing Curb? (Y/N)	N/A	N/A	DWS Offset (in)	N/A
N/A	Shared Landing?	N/A			
N/A	Gutter Ponding?	N/A	N/A	Gutter Slope (%)	N/A
N/A	Gutter Lip Ht (in)	0.5	N/A	Gutter X Slope (%)	N/A
N/A	Painted X Walk1?	No	N/A	Painted X Walk2?	N/A
	X Walk 1 Direction	To NW		X Walk 2 Direction	N/A
N/A	X Walk 1 Width (in)	N/A	N/A	X Walk 2 Width (in)	N/A
	X Walk 1 Slope (%)	0.4		X Walk 2 Slope (%)	N/A
	X Walk 1 X Slope (%)	0.8		X Walk 2 X Slope (%)	N/A

N/A	Ramp inside XWalk1?	N/A	N/A	Ramp inside XWalk2?	N/A
	Road Slope (%)	N/A	N/A	Clear Space?	N/A
	Road X Slope (%)	N/A	N/A	Clear Space to XWalk (in)	N/A
N/A	Any Obstructions?	N/A	N/A	Storm Grate/Utility Hazard?	N/A
	Obstruction Type			Storm Grate/Utility Type	
		N/A			N/A
			Yes	Surface Condition? (G/P)	Good

Possible Solutions:

**Remove & Replace Entire Ramp.**
