# Access Compliance Report

## Public Rights-of-Way

| Intersection ID: 9962 | Main Street: LITTLE ROCK RD | Cross Street: N/A | Location: | E |
| ADA ID: 3F890AE4521E | Ramp Type: Para | Initial Pass/Fail: Pass | Overall Compliance: No | Severity Score: 17.5 |

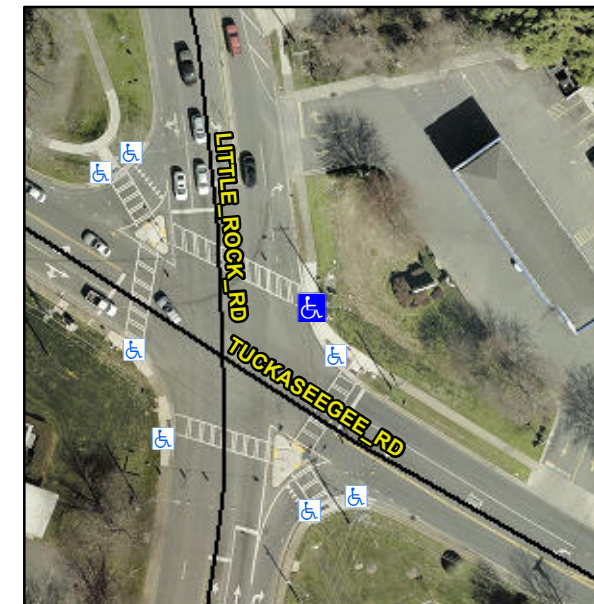
**CURB LIP 1.5, LT RP < 5%, RT RP < 5%**

**R304.2.1, R304.5.3, R305, R302.7.2**

| Compliance | Description | Data | Compliance | Description | Data |
|---|---|---|---|---|---|
| Yes | Landing Length (in) | 62.0 | No | DWS Provided? | No |
| No | Landing Width (in) | 44.0 | N/A | DWS Contrast? | No |
| No | Landing X Slope (%) | 3.3 | N/A | DWS Full Width? | No |
| No | Gutter Lip Ht (in) | 0.5 | No | Gutter X Slope (%) | 2.6 |

**Remove & Replace Entire Ramp.**  
**Remove & Replace Gutter.**

Total Cost: \$ 2350.00
