Access Compliance Report

Public Rights-of-Way

(Curb Ramps)

Intersection ID: 10028931	Main Street: IDLEWILD_RD	Cross Street: N/A	Location: SW
ADA ID: 3FA4208F5BF0	Ramp Type: PerpDiag	Initial Pass/Fail: Fail	Overall Compliance: No
Severity Score: 36.25			
Codes/Mitigation Info/Possible Solution		Field Measurements/Component Compliance

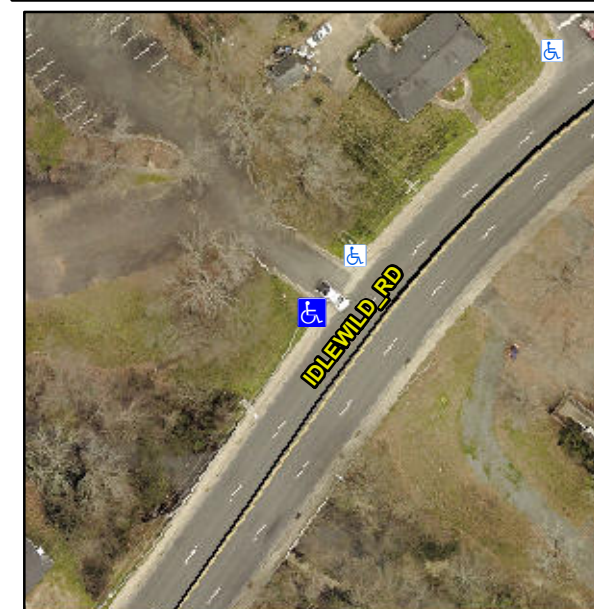
Compliance	Description	Data	Compliance	Description	Data
N/A	Ramp Length (in)	56.0	Yes	Ramp Slope (%)	6.5
No	Ramp Width (in)	31.0	Yes	Ramp XSlope (%)	2.1
N/A	Flare Type LT	N/A	N/A	Flare Type RT	N/A
N/A	Flare Slope LT (%)	N/A	N/A	Flare Slope RT (%)	N/A
N/A	Flare Traversable LT?	N/A	N/A	Flare Traversable RT?	N/A
N/A	Landing Length (in)	N/A	N/A	DWS Provided?	N/A
N/A	Landing Width (in)	N/A	N/A	DWS Contrast?	N/A
N/A	Landing Slope (%)	N/A	N/A	DWS Length (in)	N/A
N/A	Landing X Slope (%)	N/A	N/A	DWS Full Width?	N/A
N/A	Landing Curb? (Y/N)	N/A	N/A	DWS Offset (in)	N/A
N/A	Shared Landing?	N/A			
N/A	Gutter Ponding?	N/A	N/A	Gutter Slope (%)	N/A
N/A	Gutter Lip Ht (in)	1.0	N/A	Gutter X Slope (%)	N/A
N/A	Painted X Walk1?	No	N/A	Painted X Walk2?	No
	X Walk 1 Direction	To SE		X Walk 2 Direction	To NE
N/A	X Walk 1 Width (in)	N/A	N/A	X Walk 2 Width (in)	N/A
	X Walk 1 Slope (%)	2.4		X Walk 2 Slope (%)	0.8
	X Walk 1 X Slope (%)	2.0		X Walk 2 X Slope (%)	2.9

N/A	Ramp inside XWalk1?	N/A	N/A	Ramp inside XWalk2?	N/A
	Road Slope (%)	3.0	N/A	Clear Space?	N/A
	Road X Slope (%)	6.4	N/A	Clear Space to XWalk (in)	N/A
N/A	Any Obstructions?	N/A	N/A	Storm Grate/Utility Hazard?	N/A
	Obstruction Type			Storm Grate/Utility Type	
		N/A			N/A
		Yes		Surface Condition? (G/P)	Good

Remove & Replace Curb Ramp With Two New Directional Ramps or Equivalent.

R304.5.1
