Access Compliance Report

Public Rights-of-Way

(Curb Ramps)

Intersection ID: 17262	Main Street: FLORENCE_AV	Cross Street: RAMA_RD	Location:	N
ADA ID: 3FB439AEF3A2	Ramp Type: PerpDiag	Initial Pass/Fail: Fail	Overall Compliance: No	Severity Score: 13.75
Codes/Mitigation Info/Possible Solution		Field Measurements/Component Compliance

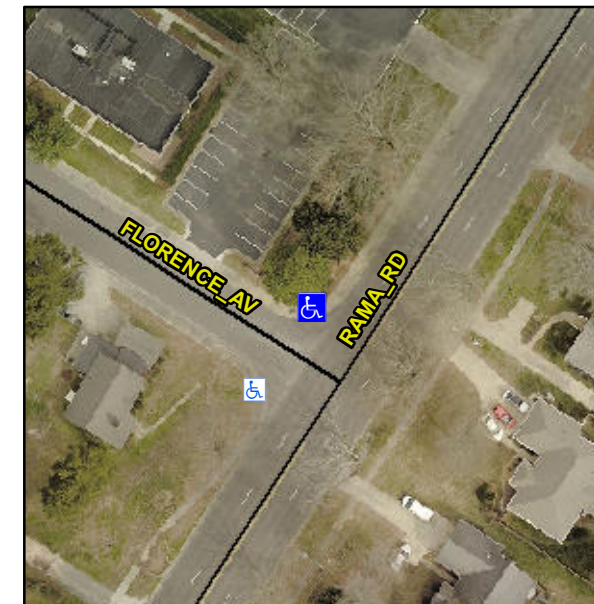
Not Found, R304.2.2, R304.5.3

Compliance	Description	Data	Compliance	Description	Data
N/A	Ramp Length (in)	61.0	No	Ramp Slope (%)	8.7
Yes	Ramp Width (in)	48.0	No	Ramp XSlope (%)	3.2
N/A	Flare Type LT	N/A	N/A	Flare Type RT	N/A
N/A	Flare Slope LT (%)	N/A	N/A	Flare Slope RT (%)	N/A
N/A	Flare Traversable LT?	N/A	N/A	Flare Traversable RT?	N/A
N/A	Landing Length (in)	N/A	N/A	DWS Provided?	N/A
N/A	Landing Width (in)	N/A	N/A	DWS Contrast?	N/A
N/A	Landing Slope (%)	N/A	N/A	DWS Length (in)	N/A
N/A	Landing X Slope (%)	N/A	N/A	DWS Full Width?	N/A
N/A	Landing Curb? (Y/N)	N/A	N/A	DWS Offset (in)	N/A
N/A	Shared Landing?	N/A			
N/A	Gutter Ponding?	N/A	N/A	Gutter Slope (%)	N/A
N/A	Gutter Lip Ht (in)	N/A	N/A	Gutter X Slope (%)	N/A
N/A	Painted X Walk1?	No	N/A	Painted X Walk2?	No
	X Walk 1 Direction	To SW		X Walk 2 Direction	To SE
N/A	X Walk 1 Width (in)	N/A	N/A	X Walk 2 Width (in)	N/A
	X Walk 1 Slope (%)	2.8		X Walk 2 Slope (%)	2.9
	X Walk 1 X Slope (%)	3.0		X Walk 2 X Slope (%)	3.5

N/A	Ramp inside XWalk1?	N/A	N/A	Ramp inside XWalk2?	N/A
	Road Slope (%)	2.8	N/A	Clear Space?	N/A
	Road X Slope (%)	1.8	N/A	Clear Space to XWalk (in)	N/A
N/A	Any Obstructions?	N/A	N/A	Storm Grate/Utility Hazard?	N/A
	Obstruction Type			Storm Grate/Utility Type	
		N/A			N/A
			Yes	Surface Condition? (G/P)	Good

Remove & Replace Curb Ramp With Two New Directional Ramps or Equivalent.
