Access Compliance Report

Public Rights-of-Way

(Curb Ramps)

Intersection ID: 11741	Main Street: COUNTRY CLUB DR	Cross Street: MATHESON AV	Location:	E
ADA ID: 3FB75ED33F1F	Ramp Type: Perp	Initial Pass/Fail: Fail	Overall Compliance: No	Severity Score: 10
Codes/Mitigation Info/Possible Solution		Field Measurements/Component Compliance

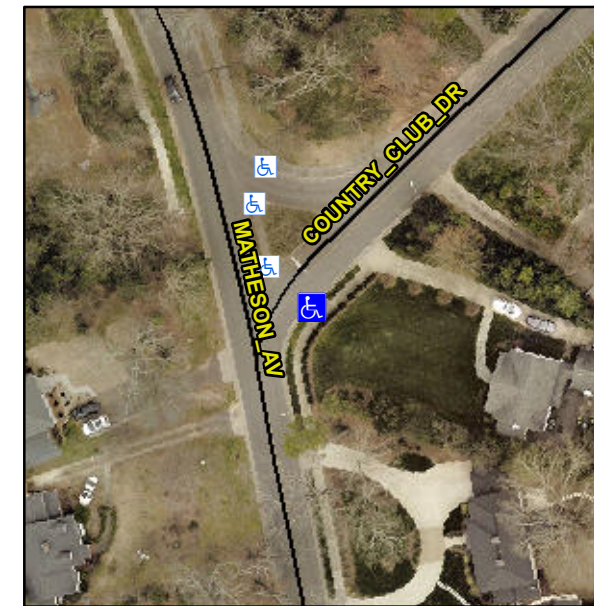
Not Found, R304.5.1, R304.5.3

Compliance	Description	Data	Compliance	Description	Data
N/A	Ramp Length (in)	50.0	Yes	Ramp Slope (%)	5.2
No	Ramp Width (in)	44.0	No	Ramp XSlope (%)	3.1
N/A	Flare Type LT	N/A	N/A	Flare Type RT	N/A
N/A	Flare Slope LT (%)	N/A	N/A	Flare Slope RT (%)	N/A
N/A	Flare Traversable LT?	N/A	N/A	Flare Traversable RT?	N/A
N/A	Landing Length (in)	N/A	N/A	DWS Provided?	N/A
N/A	Landing Width (in)	N/A	N/A	DWS Contrast?	N/A
N/A	Landing Slope (%)	N/A	N/A	DWS Length (in)	N/A
N/A	Landing X Slope (%)	N/A	N/A	DWS Full Width?	N/A
N/A	Landing Curb? (Y/N)	N/A	N/A	DWS Offset (in)	N/A
N/A	Shared Landing?	N/A			
N/A	Gutter Ponding?	N/A	N/A	Gutter Slope (%)	N/A
N/A	Gutter Lip Ht (in)	N/A	N/A	Gutter X Slope (%)	N/A
N/A	Painted X Walk1?	No	N/A	Painted X Walk2?	N/A
	X Walk 1 Direction	To N		X Walk 2 Direction	N/A
N/A	X Walk 1 Width (in)	N/A	N/A	X Walk 2 Width (in)	N/A
	X Walk 1 Slope (%)	3.0		X Walk 2 Slope (%)	N/A
	X Walk 1 X Slope (%)	4.5		X Walk 2 X Slope (%)	N/A

N/A	Ramp inside XWalk1?	N/A	N/A	Ramp inside XWalk2?	N/A
	Road Slope (%)	N/A	N/A	Clear Space?	N/A
	Road X Slope (%)	N/A	N/A	Clear Space to XWalk (in)	N/A
N/A	Any Obstructions?	N/A	N/A	Storm Grate/Utility Hazard?	N/A
	Obstruction Type			Storm Grate/Utility Type	
		N/A			N/A
			Yes	Surface Condition? (G/P)	Good

Possible Solutions:

Remove & Replace Entire Ramp.
