# Access Compliance Report

## Public Rights-of-Way

### (Curb Ramps)

Intersection ID: 4516	Main Street: ASTORIA_DR	Cross Street: DASHIEL_DR	Location: NW
ADA ID: 3FB8FE610464	Ramp Type: BlendTrans1	Initial Pass/Fail: Fail	Overall Compliance: No
		Severity Score: 10

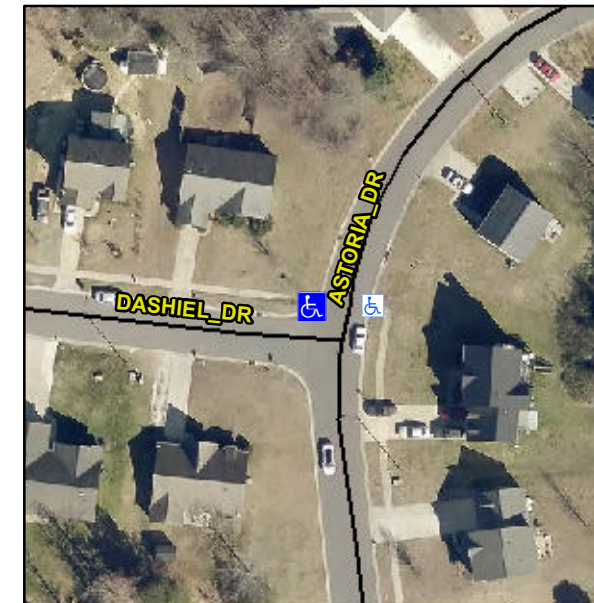
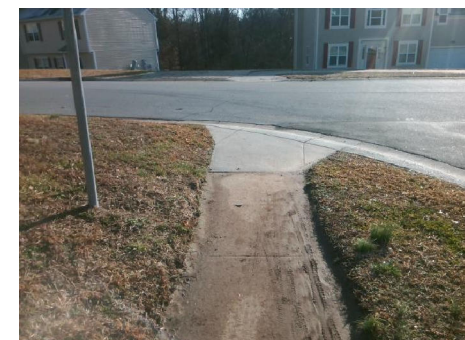
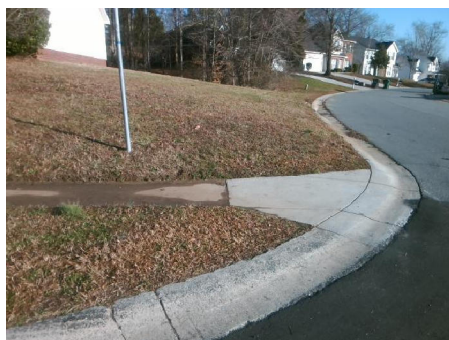
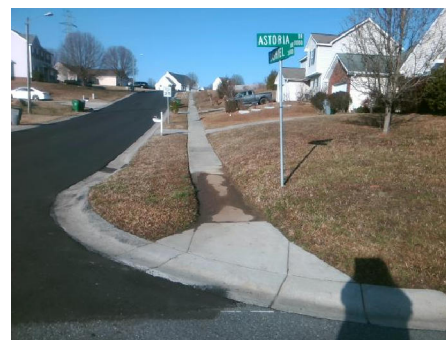
**Not Found, R304.5.1, R304.5.3**

Compliance	Description	Data	Compliance	Description	Data
N/A	Ramp Length (in)	48.0	Yes	BlendTrans Slope (%)	2.3
No	Ramp Width (in)	44.0	No	BlendTrans XSlope (%)	4.0
N/A	Flare Type LT	N/A	N/A	Flare Type RT	N/A
N/A	Flare Slope LT (%)	N/A	N/A	Flare Slope RT (%)	N/A
N/A	Flare Traversable LT?	N/A	N/A	Flare Traversable RT?	N/A
N/A	Landing Length (in)	N/A	N/A	DWS Provided?	N/A
N/A	Landing Width (in)	N/A	N/A	DWS Contrast?	N/A
N/A	Landing Slope (%)	N/A	N/A	DWS Length (in)	N/A
N/A	Landing X Slope (%)	N/A	N/A	DWS Full Width?	N/A
N/A	Landing Curb? (Y/N)	N/A	N/A	DWS Offset (in)	N/A
N/A	Shared Landing?	N/A			
N/A	Gutter Ponding?	N/A	N/A	Gutter Slope (%)	N/A
N/A	Gutter Lip Ht (in)	N/A	N/A	Gutter X Slope (%)	N/A
N/A	Painted X Walk1?	No	N/A	Painted X Walk2?	N/A
	X Walk 1 Direction	To E		X Walk 2 Direction	N/A
	X Walk 1 Width (in)	N/A		X Walk 2 Width (in)	N/A
	X Walk 1 Slope (%)	2.2		X Walk 2 Slope (%)	N/A
	X Walk 1 X Slope (%)	0.6		X Walk 2 X Slope (%)	N/A

N/A	Ramp inside XWalk1?	N/A	N/A	Ramp inside XWalk2?	N/A
	Road Slope (%)	0.6		Clear Space?	N/A
	Road X Slope (%)	2.2	N/A	Clear Space to XWalk (in)	N/A
N/A	Any Obstructions?	N/A	N/A	Storm Grate/Utility Hazard?	N/A
	Obstruction Type			Storm Grate/Utility Type	
		N/A			N/A
			Yes	Surface Condition? (G/P)	Good
			No	Curb Slope (%)	18.5

**Remove & Replace Curb Ramp With Two New Directional Ramps or Equivalent.**
