Access Compliance Report

Public Rights-of-Way

(Curb Ramps)

Intersection ID: 21135	Main Street: ALLISON_AV	Cross Street: SHARON_VIEW_RD	Location: NE
ADA ID: 3FBABF2FC1D8	Ramp Type: PerpDiag	Initial Pass/Fail: Fail	Overall Compliance: No
			Severity Score: 33.75

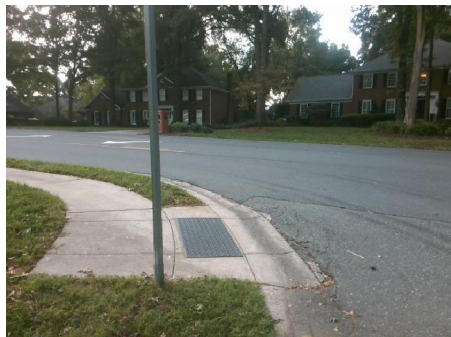
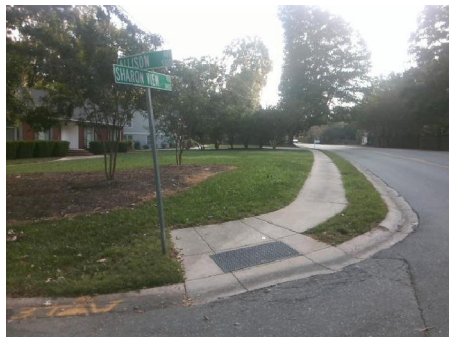
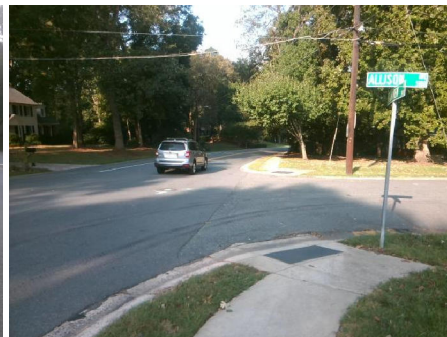
Not Found, R304.5.1, R304.5.3

Compliance	Description	Data	Compliance	Description	Data
N/A	Ramp Length (in)	77.0	Yes	Ramp Slope (%)	6.1
No	Ramp Width (in)	36.0	No	Ramp XSlope (%)	10.1
N/A	Flare Type LT	N/A	N/A	Flare Type RT	N/A
N/A	Flare Slope LT (%)	N/A	N/A	Flare Slope RT (%)	N/A
N/A	Flare Traversable LT?	N/A	N/A	Flare Traversable RT?	N/A
N/A	Landing Length (in)	N/A	N/A	DWS Provided?	N/A
N/A	Landing Width (in)	N/A	N/A	DWS Contrast?	N/A
N/A	Landing Slope (%)	N/A	N/A	DWS Length (in)	N/A
N/A	Landing X Slope (%)	N/A	N/A	DWS Full Width?	N/A
N/A	Landing Curb? (Y/N)	N/A	N/A	DWS Offset (in)	N/A
N/A	Shared Landing?	N/A			
N/A	Gutter Ponding?	N/A	N/A	Gutter Slope (%)	N/A
N/A	Gutter Lip Ht (in)	N/A	N/A	Gutter X Slope (%)	N/A
N/A	Painted X Walk1?	No	N/A	Painted X Walk2?	No
	X Walk 1 Direction	To W		X Walk 2 Direction	To S
N/A	X Walk 1 Width (in)	N/A	N/A	X Walk 2 Width (in)	N/A
	X Walk 1 Slope (%)	1.0		X Walk 2 Slope (%)	7.8
	X Walk 1 X Slope (%)	7.3		X Walk 2 X Slope (%)	1.6

N/A	Ramp inside XWalk1?	N/A	N/A	Ramp inside XWalk2?	N/A
	Road Slope (%)	8.6	N/A	Clear Space?	N/A
	Road X Slope (%)	6.5	N/A	Clear Space to XWalk (in)	N/A
N/A	Any Obstructions?	N/A	N/A	Storm Grate/Utility Hazard?	N/A
	Obstruction Type			Storm Grate/Utility Type	
		N/A			N/A
			Yes	Surface Condition? (G/P)	Good

Remove & Replace Curb Ramp With Two New Directional Ramps or Equivalent.
