Access Compliance Report

Public Rights-of-Way

(Curb Ramps)

Intersection ID: 31631	Main Street: PLAZA_WALK_DR	Cross Street: N/A	Location: NW
ADA ID: 3FC0F739E0B1	Ramp Type: BlendTrans1	Initial Pass/Fail: Fail	Overall Compliance: No
Codes/Mitigation Info/Possible Solution		Field Measurements/Component Compliance	
		Severity Score: 8.75

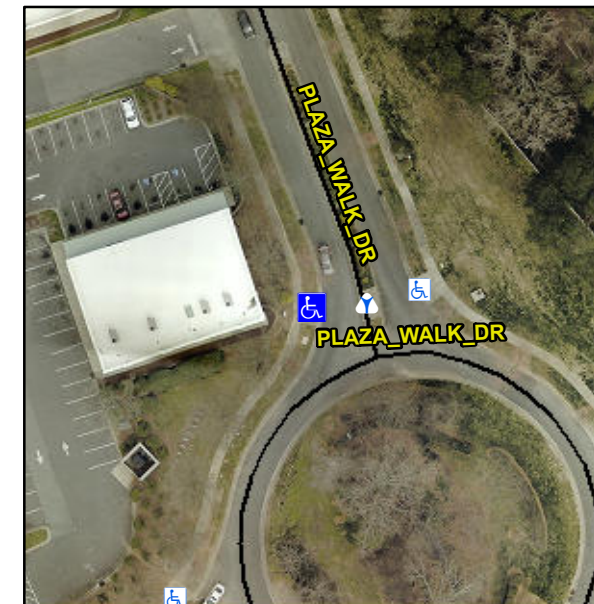
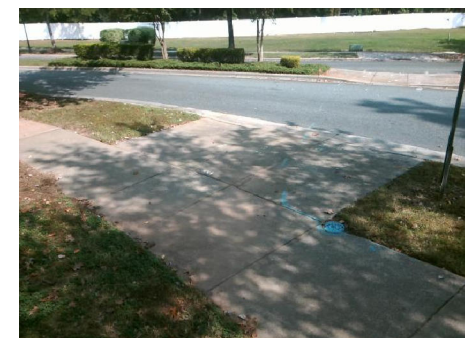
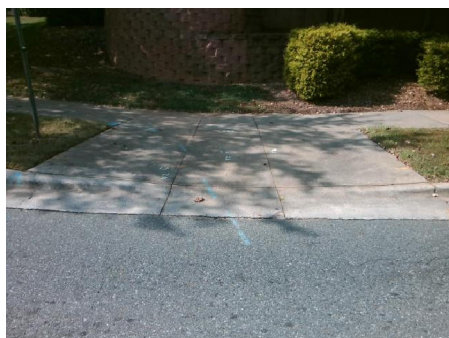
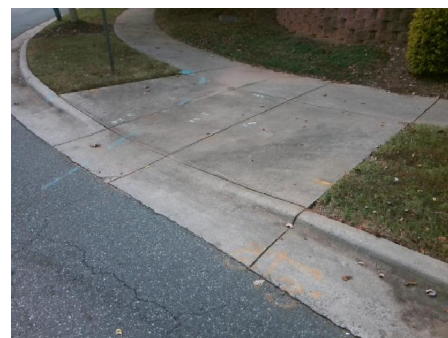
RP < 5%

Not Found, R304.5.1

Compliance	Description	Data	Compliance	Description	Data
N/A	Ramp Length (in)	96.5	Yes	BlendTrans Slope (%)	2.3
No	Ramp Width (in)	43.5	Yes	BlendTrans XSlope (%)	0.5
N/A	Flare Type LT	N/A	N/A	Flare Type RT	N/A
N/A	Flare Slope LT (%)	N/A	N/A	Flare Slope RT (%)	N/A
N/A	Flare Traversable LT?	N/A	N/A	Flare Traversable RT?	N/A
N/A	Landing Length (in)	N/A	N/A	DWS Provided?	N/A
N/A	Landing Width (in)	N/A	N/A	DWS Contrast?	N/A
N/A	Landing Slope (%)	N/A	N/A	DWS Length (in)	N/A
N/A	Landing X Slope (%)	N/A	N/A	DWS Full Width?	N/A
N/A	Landing Curb? (Y/N)	N/A	N/A	DWS Offset (in)	N/A
N/A	Shared Landing?	N/A			
N/A	Gutter Ponding?	N/A	N/A	Gutter Slope (%)	N/A
N/A	Gutter Lip Ht (in)	N/A	N/A	Gutter X Slope (%)	N/A
N/A	Painted X Walk1?	No	N/A	Painted X Walk2?	N/A
	X Walk 1 Direction	To E		X Walk 2 Direction	N/A
	X Walk 1 Width (in)	N/A		X Walk 2 Width (in)	N/A
	X Walk 1 Slope (%)	2.0		X Walk 2 Slope (%)	N/A
	X Walk 1 X Slope (%)	1.3		X Walk 2 X Slope (%)	N/A

N/A	Ramp inside XWalk1?	N/A	N/A	Ramp inside XWalk2?	N/A
	Road Slope (%)	1.3		Clear Space?	N/A
	Road X Slope (%)	2.0	N/A	Clear Space to XWalk (in)	N/A
N/A	Any Obstructions?	N/A	N/A	Storm Grate/Utility Hazard?	N/A
	Obstruction Type			Storm Grate/Utility Type	
		N/A			N/A
			Yes	Surface Condition? (G/P)	Good
			No	Curb Slope (%)	6.2

Possible Solutions:

Remove & Replace Curb Ramp With Two New Directional Ramps or Equivalent.
