Access Compliance Report

Public Rights-of-Way

(Curb Ramps)

| Intersection ID: 10026800 | Main Street: FOREST_POINT_BV | Cross Street: N/A | Location: NW |

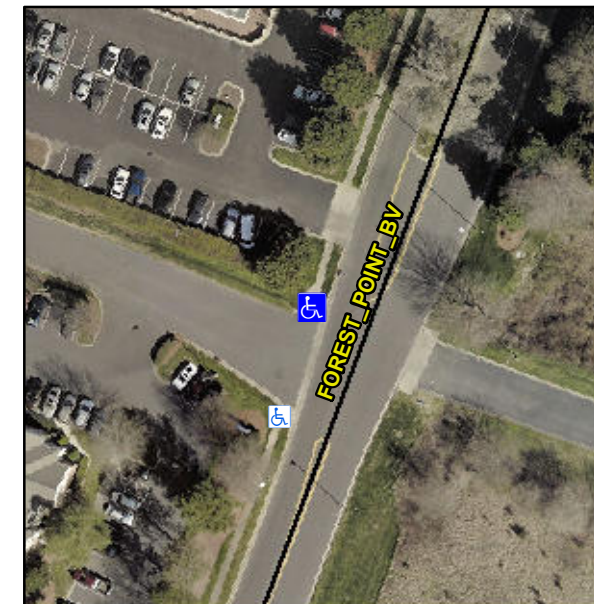
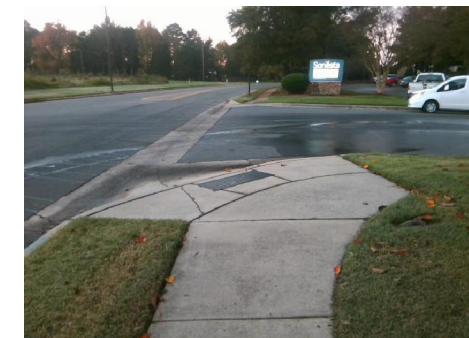
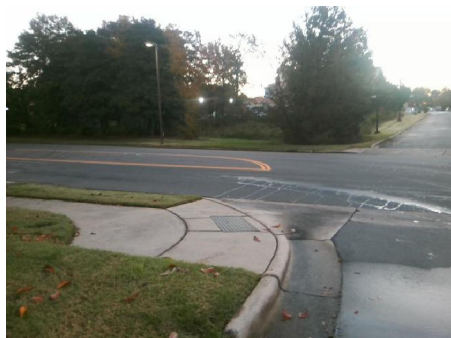
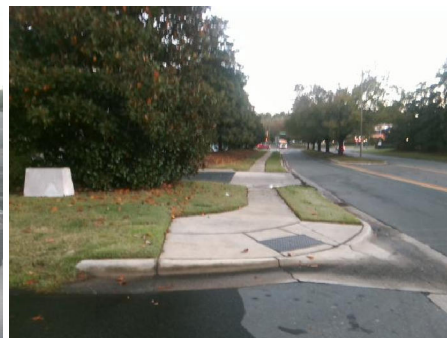
Not Found, R304.5.1, R304.2.2

| Compliance | Description | Data | Compliance | Description | Data |
|---|---|---|---|---|---|
| N/A | Ramp Length (in) | 52.0 | No | Ramp Slope (%) | 8.8 |
| No | Ramp Width (in) | 35.0 | Yes | Ramp XSlope (%) | 4.9 |

Remove & Replace Curb Ramp With Two New Directional Ramps or Equivalent.
