Access Compliance Report

Public Rights-of-Way

(Curb Ramps)

Intersection ID: 12676	Main Street: PENCE_RD	Cross Street: HICKORY_GROVE_RD	Location: NE
ADA ID: 3FC6E44953FF	Ramp Type: PerpDiag	Initial Pass/Fail: Fail	Overall Compliance: No
		Severity Score: 22.5

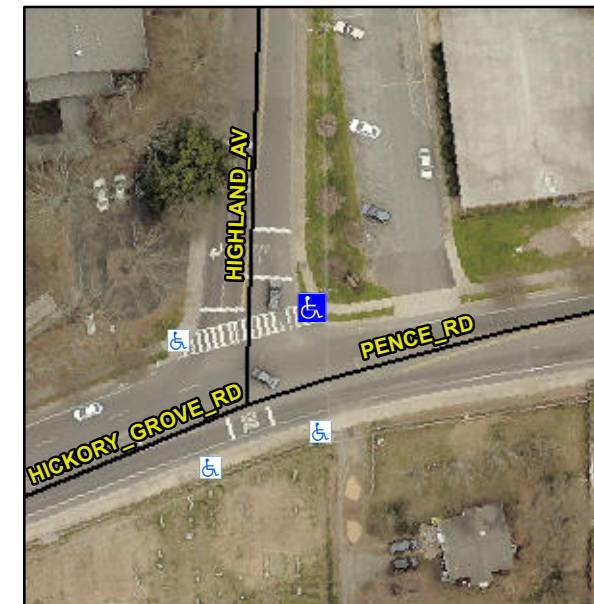
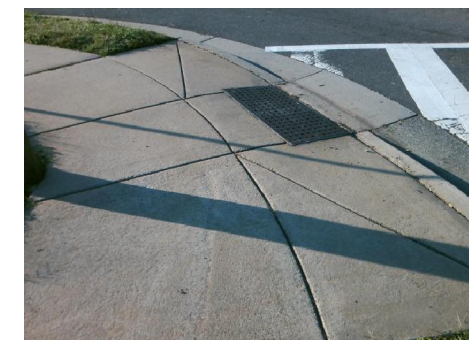
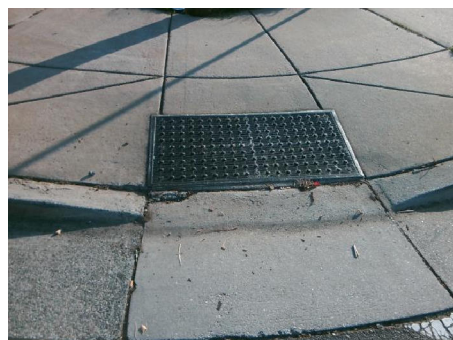
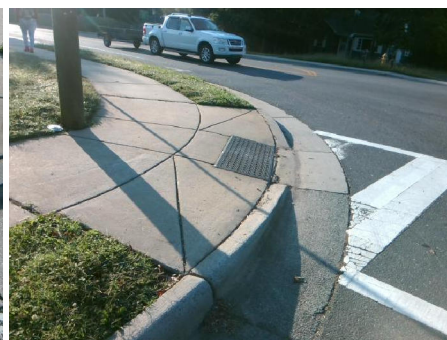
Not Found, R304.5.1, R304.2.2, R304.5.3

Compliance	Description	Data	Compliance	Description	Data
N/A	Ramp Length (in)	42.5	No	Ramp Slope (%)	11.3
No	Ramp Width (in)	39.0	No	Ramp XSlope (%)	2.1
N/A	Flare Type LT	N/A	N/A	Flare Type RT	N/A
N/A	Flare Slope LT (%)	N/A	N/A	Flare Slope RT (%)	N/A
N/A	Flare Traversable LT?	N/A	N/A	Flare Traversable RT?	N/A
N/A	Landing Length (in)	N/A	N/A	DWS Provided?	N/A
N/A	Landing Width (in)	N/A	N/A	DWS Contrast?	N/A
N/A	Landing Slope (%)	N/A	N/A	DWS Length (in)	N/A
N/A	Landing X Slope (%)	N/A	N/A	DWS Full Width?	N/A
N/A	Landing Curb? (Y/N)	N/A	N/A	DWS Offset (in)	N/A
N/A	Shared Landing?	N/A			
N/A	Gutter Ponding?	N/A	N/A	Gutter Slope (%)	N/A
N/A	Gutter Lip Ht (in)	N/A	N/A	Gutter X Slope (%)	N/A
N/A	Painted X Walk1?	Yes	N/A	Painted X Walk2?	No
	X Walk 1 Direction	To W		X Walk 2 Direction	To S
N/A	X Walk 1 Width (in)	117.0	N/A	X Walk 2 Width (in)	N/A
	X Walk 1 Slope (%)	2.4		X Walk 2 Slope (%)	3.4
	X Walk 1 X Slope (%)	4.2		X Walk 2 X Slope (%)	2.1

N/A	Ramp inside XWalk1?	Yes	N/A	Ramp inside XWalk2?	N/A
	Road Slope (%)	3.0	N/A	Clear Space?	N/A
	Road X Slope (%)	4.3	N/A	Clear Space to XWalk (in)	N/A
N/A	Any Obstructions?	N/A	N/A	Storm Grate/Utility Hazard?	N/A
	Obstruction Type			Storm Grate/Utility Type	
		N/A			N/A
			Yes	Surface Condition? (G/P)	Good

Remove & Replace Curb Ramp With Two New Directional Ramps or Equivalent.

Total Cost: \$ 3200.00
