Access Compliance Report

Public Rights-of-Way

(Curb Ramps)

Intersection ID: 23663	Main Street: S_TRYON_ST	Cross Street: ERWIN_RD	Location: NW
ADA ID: 3FD9CFB2A0FC	Ramp Type: Perp	Initial Pass/Fail: Fail	Overall Compliance: No
Severity Score: 22.5			
Codes/Mitigation Info/Possible Solution		Field Measurements/Component Compliance

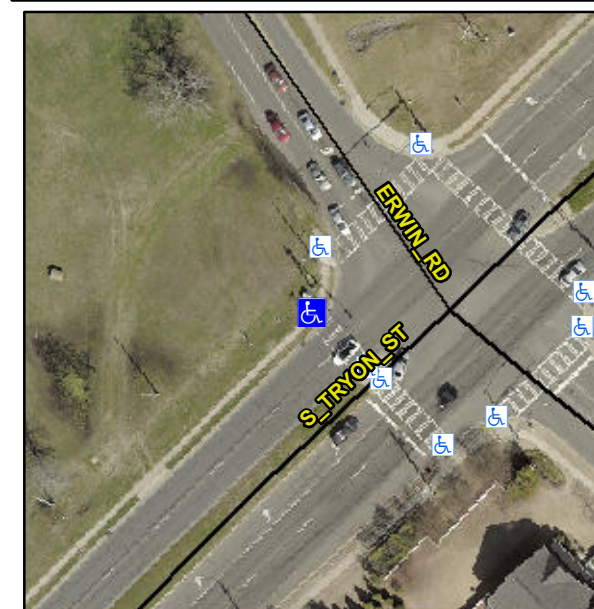
Not Found, R304.5.1, R304.2.2, R304.5.3

Compliance	Description	Data	Compliance	Description	Data
N/A	Ramp Length (in)	48.0	No	Ramp Slope (%)	8.6
No	Ramp Width (in)	46.0	No	Ramp XSlope (%)	2.3
N/A	Flare Type LT	N/A	N/A	Flare Type RT	N/A
N/A	Flare Slope LT (%)	N/A	N/A	Flare Slope RT (%)	N/A
N/A	Flare Traversable LT?	N/A	N/A	Flare Traversable RT?	N/A
N/A	Landing Length (in)	N/A	N/A	DWS Provided?	N/A
N/A	Landing Width (in)	N/A	N/A	DWS Contrast?	N/A
N/A	Landing Slope (%)	N/A	N/A	DWS Length (in)	N/A
N/A	Landing X Slope (%)	N/A	N/A	DWS Full Width?	N/A
N/A	Landing Curb? (Y/N)	N/A	N/A	DWS Offset (in)	N/A
N/A	Shared Landing?	N/A			
N/A	Gutter Ponding?	N/A	N/A	Gutter Slope (%)	N/A
N/A	Gutter Lip Ht (in)	N/A	N/A	Gutter X Slope (%)	N/A
N/A	Painted X Walk1?	Yes	N/A	Painted X Walk2?	N/A
	X Walk 1 Direction	To SE		X Walk 2 Direction	N/A
N/A	X Walk 1 Width (in)	115.0	N/A	X Walk 2 Width (in)	N/A
	X Walk 1 Slope (%)	2.0		X Walk 2 Slope (%)	N/A
	X Walk 1 X Slope (%)	0.4		X Walk 2 X Slope (%)	N/A

N/A	Ramp inside XWalk1?	Yes	N/A	Ramp inside XWalk2?	N/A
	Road Slope (%)	N/A	N/A	Clear Space?	N/A
	Road X Slope (%)	N/A	N/A	Clear Space to XWalk (in)	N/A
N/A	Any Obstructions?	N/A	N/A	Storm Grate/Utility Hazard?	N/A
	Obstruction Type			Storm Grate/Utility Type	
		N/A			N/A
			Yes	Surface Condition? (G/P)	Good

Possible Solutions:

Remove & Replace Entire Ramp.
