Access Compliance Report

Public Rights-of-Way

(Curb Ramps)

Intersection ID: 48770	Main Street: TURNING_WHEEL_DR	Cross Street: KNOTHOLE_LN	Location: NW
ADA ID: 3FE0A4B68E9D	Ramp Type: PerpDiag	Initial Pass/Fail: Fail	Overall Compliance: No
Severity Score: 8.75			
Codes/Mitigation Info/Possible Solution		Field Measurements/Component Compliance

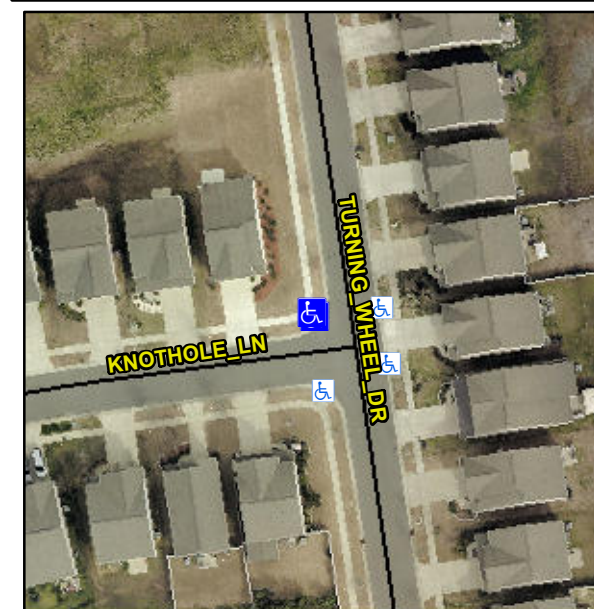
Compliance	Description	Data	Compliance	Description	Data
N/A	Ramp Length (in)	72.0	Yes	Ramp Slope (%)	7.2
No	Ramp Width (in)	46.0	Yes	Ramp XSlope (%)	1.0
N/A	Flare Type LT	N/A	N/A	Flare Type RT	N/A
N/A	Flare Slope LT (%)	N/A	N/A	Flare Slope RT (%)	N/A
N/A	Flare Traversable LT?	N/A	N/A	Flare Traversable RT?	N/A
N/A	Landing Length (in)	N/A	N/A	DWS Provided?	N/A
N/A	Landing Width (in)	N/A	N/A	DWS Contrast?	N/A
N/A	Landing Slope (%)	N/A	N/A	DWS Length (in)	N/A
N/A	Landing X Slope (%)	N/A	N/A	DWS Full Width?	N/A
N/A	Landing Curb? (Y/N)	N/A	N/A	DWS Offset (in)	N/A
N/A	Shared Landing?	N/A			
N/A	Gutter Ponding?	N/A	N/A	Gutter Slope (%)	N/A
N/A	Gutter Lip Ht (in)	N/A	N/A	Gutter X Slope (%)	N/A
N/A	Painted X Walk1?	No	N/A	Painted X Walk2?	No
	X Walk 1 Direction	To S		X Walk 2 Direction	To E
N/A	X Walk 1 Width (in)	N/A	N/A	X Walk 2 Width (in)	N/A
	X Walk 1 Slope (%)	5.1		X Walk 2 Slope (%)	3.6
	X Walk 1 X Slope (%)	2.6		X Walk 2 X Slope (%)	2.0

N/A	Ramp inside XWalk1?	N/A	N/A	Ramp inside XWalk2?	N/A
	Road Slope (%)	0.6	N/A	Clear Space?	N/A
	Road X Slope (%)	5.1	N/A	Clear Space to XWalk (in)	N/A
N/A	Any Obstructions?	N/A	N/A	Storm Grate/Utility Hazard?	N/A
	Obstruction Type			Storm Grate/Utility Type	
		N/A			N/A
		Yes		Surface Condition? (G/P)	Good

Remove & Replace Curb Ramp With Two New Directional Ramps or Equivalent.

R304.5.1
