# Access Compliance Report

## Public Rights-of-Way

### (Curb Ramps)

Intersection ID: 14541	Main Street: FARM_POND_LN	Cross Street: SNOWCREST_CT	Location: SE
ADA ID: 3FE5DAEB91BB	Ramp Type: Directional1	Initial Pass/Fail: Fail	Overall Compliance: No
Severity Score: 33.75			
Codes/Mitigation Info/Possible Solution		Field Measurements/Component Compliance

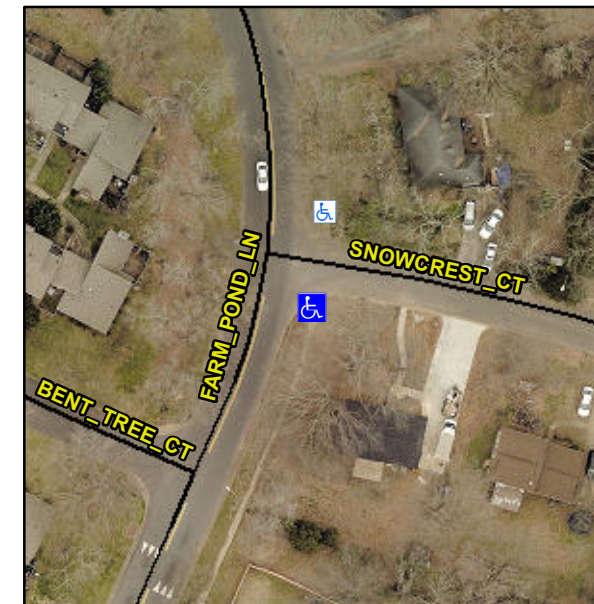
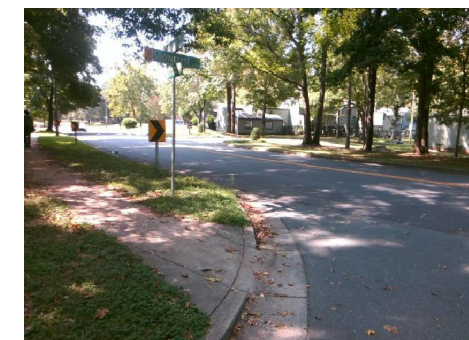
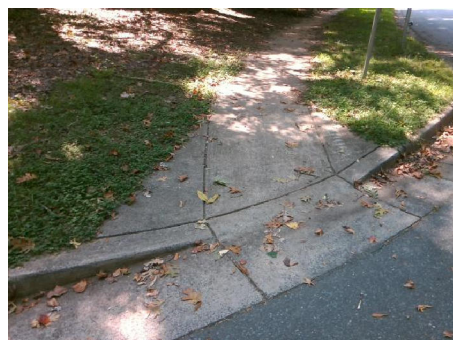
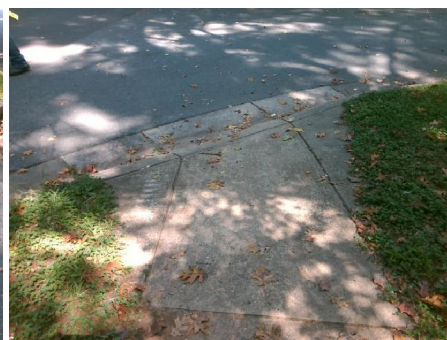
Compliance	Description	Data	Compliance	Description	Data
N/A	Ramp Length (in)	63.5	N/A	Grade Break?	N/A
No	Ramp Width (in)	42.0	N/A	Grade Break Slope (%)	0.0
No	Ramp Slope (%)	8.4	N/A	Grade Break XSlope (%)	0.0
No	Ramp XSlope (%)	5.4			
N/A	Flare Type LT	N/A	N/A	Flare Type RT	N/A
N/A	Flare Slope LT (%)	N/A	N/A	Flare Slope RT (%)	0.0
N/A	Flare Traversable LT?	N/A	N/A	Flare Traversable RT?	N/A
N/A	Landing Length (in)	0.0	N/A	DWS Provided?	N/A
N/A	Landing Width (in)	0.0	N/A	DWS Contrast?	N/A
N/A	Landing Slope (%)	0.0	N/A	DWS Length (in)	N/A
N/A	Landing X Slope (%)	0.0	N/A	DWS Full Width?	N/A
N/A	Landing Curb? (Y/N)	N/A	N/A	DWS Offset LT (in)	N/A
N/A	Shared Landing?	N/A	N/A	DWS Offset RT (in)	N/A
N/A	Gutter Ponding?	0.0	N/A	Gutter Slope (%)	N/A
N/A	Gutter Lip Ht (in)	0.0	N/A	Gutter X Slope (%)	N/A
N/A	Painted X Walk1?	No		Road Slope (%)	1.5
	X Walk 1 Direction	To N		Road X Slope (%)	1.9
	X Walk 1 Width (in)	N/A		Clear Space?	N/A

X Walk 1 Slope (%)	1.5	N/A	Clear Space to XWalk (in)	N/A
	X Walk 1 X Slope (%)	1.9	N/A	Storm Grate/Utility Hazard?	N/A
N/A	Ramp inside XWalk1?	N/A		Storm Grate/Utility Type	
N/A	Any Obstructions?	N/A			N/A
	Obstruction Type		Yes	Surface Condition? (G/P)	Good
			N/A	Curb Slope (%)	18.3

**Remove & Replace Entire Ramp.**

**R304.5.1, R304.2.2, R304.5.3**
