Access Compliance Report

Public Rights-of-Way

(Curb Ramps)

Intersection ID: 11109	Main Street: COLEBROOK_RD	Cross Street: MEADOWCLIFF_DR	Location: NE
ADA ID: 3FEBC4514F00	Ramp Type: Perp	Initial Pass/Fail: Fail	Overall Compliance: No
Codes/Mitigation Info/Possible Solution			Severity Score: 10
			Field Measurements/Component Compliance

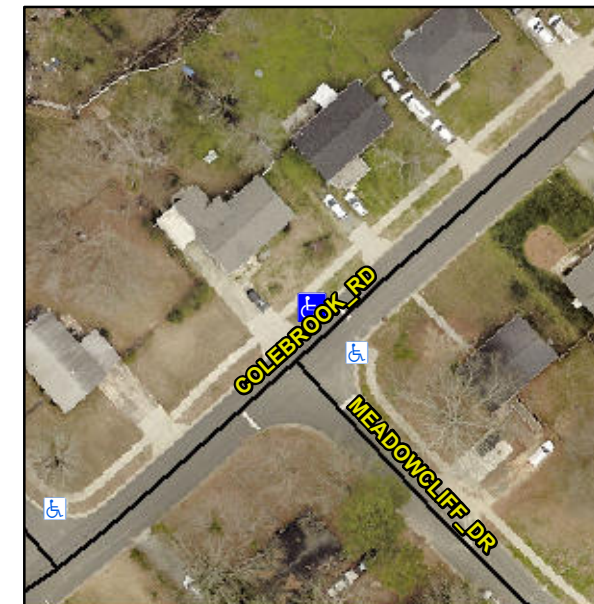
Compliance	Description	Data	Compliance	Description	Data
N/A	Ramp Length (in)	97.0	Yes	Ramp Slope (%)	6.7
No	Ramp Width (in)	47.5	No	Ramp XSlope (%)	2.7
N/A	Flare Type LT	N/A	N/A	Flare Type RT	N/A
N/A	Flare Slope LT (%)	N/A	N/A	Flare Slope RT (%)	N/A
N/A	Flare Traversable LT?	N/A	N/A	Flare Traversable RT?	N/A
N/A	Landing Length (in)	N/A	N/A	DWS Provided?	N/A
N/A	Landing Width (in)	N/A	N/A	DWS Contrast?	N/A
N/A	Landing Slope (%)	N/A	N/A	DWS Length (in)	N/A
N/A	Landing X Slope (%)	N/A	N/A	DWS Full Width?	N/A
N/A	Landing Curb? (Y/N)	N/A	N/A	DWS Offset (in)	N/A
N/A	Shared Landing?	N/A			
N/A	Gutter Ponding?	N/A	N/A	Gutter Slope (%)	N/A
N/A	Gutter Lip Ht (in)	N/A	N/A	Gutter X Slope (%)	N/A
N/A	Painted X Walk1?	No	N/A	Painted X Walk2?	N/A
	X Walk 1 Direction	To SE		X Walk 2 Direction	N/A
N/A	X Walk 1 Width (in)	N/A	N/A	X Walk 2 Width (in)	N/A
	X Walk 1 Slope (%)	1.2		X Walk 2 Slope (%)	N/A
	X Walk 1 X Slope (%)	2.1		X Walk 2 X Slope (%)	N/A

N/A	Ramp inside XWalk1?	N/A	N/A	Ramp inside XWalk2?	N/A
	Road Slope (%)	N/A	N/A	Clear Space?	N/A
	Road X Slope (%)	N/A	N/A	Clear Space to XWalk (in)	N/A
N/A	Any Obstructions?	N/A	N/A	Storm Grate/Utility Hazard?	N/A
	Obstruction Type			Storm Grate/Utility Type	
		N/A			N/A
			Yes	Surface Condition? (G/P)	Good

Possible Solutions:

Remove & Replace Entire Ramp.

R304.5.1, R304.5.3
