# Access Compliance Report

## Public Rights-of-Way

| Intersection ID: 49294 | Main Street: ELIZABETH_CREST_LN | Cross Street: CREEKSIDE_PARK_RD | Location: NW |
| ADA ID: 3FF178D6B305 | Ramp Type: BlendTrans1 | Initial Pass/Fail: Pass | Overall Compliance: No |

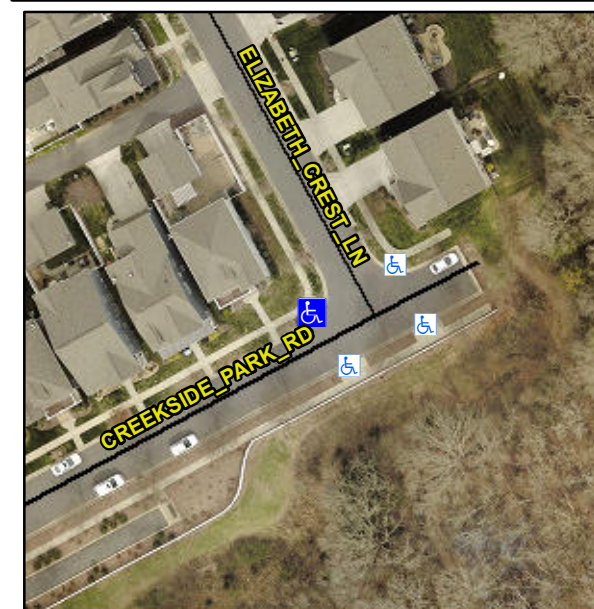
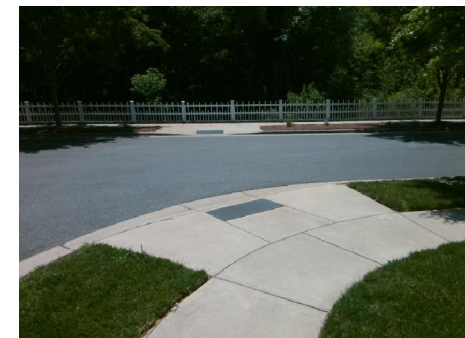
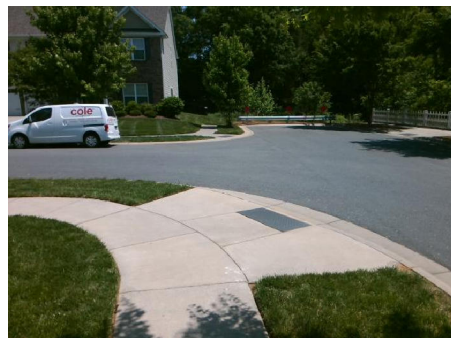
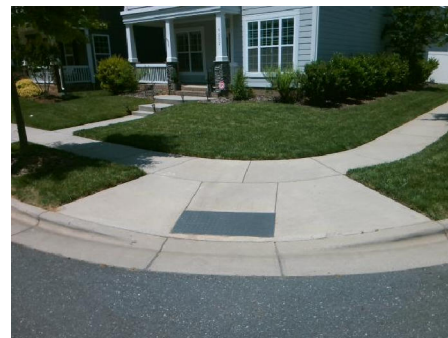
**Not Found, R304.2.2-Perp, R304.3.2-Para, R305.2**

| Compliance | Description | Data | Compliance | Description | Data |
|---|---|---|---|---|---|
| No | Landing Slope (%) | 3.7 | Yes | DWS Length (in) | 24.0 |
| N/A | Landing Curb? (Y/N) | No | No | DWS Offset (in) | 4.5 |
| | | | No | Curb Slope (%) | 15.5 |

**Remove & Replace Curb Ramp With Two New Directional Ramps or Equivalent.**

Total Cost: \$ 3200.00
