Access Compliance Report

Public Rights-of-Way

(Curb Ramps)

Intersection ID: 4185	Main Street: BRIARTHORNE_DR	Cross Street: HARRIS_POINTE_DR	Location:	N
ADA ID: 3FF242935CF4	Ramp Type: Perp	Initial Pass/Fail: Fail	Overall Compliance: No	Severity Score: 50

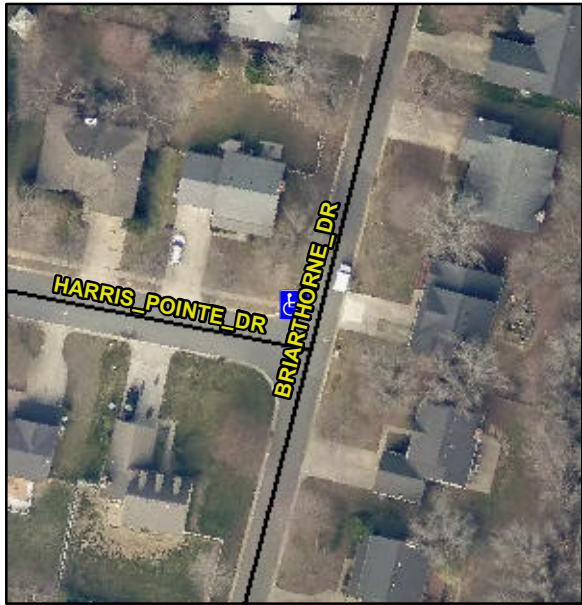
Possible Solutions:		Compliance	Description	Data	Compliance	Description	Data
	Remove & Replace Entire Ramp.		N/A	Ramp Length (in)	60.5	No	Ramp Slope (%)	12.2
			Yes	Ramp Width (in)	48.0	No	Ramp XSlope (%)	8.3
			N/A	Flare Type LT	N/A	N/A	Flare Type RT	N/A
			N/A	Flare Slope LT (%)	N/A	N/A	Flare Slope RT (%)	N/A
			N/A	Flare Traversable LT?	N/A	N/A	Flare Traversable RT?	N/A
			N/A	Landing Length (in)	N/A	N/A	DWS Provided?	N/A
			N/A	Landing Width (in)	N/A	N/A	DWS Contrast?	N/A
			N/A	Landing Slope (%)	N/A	N/A	DWS Length (in)	N/A
			N/A	Landing X Slope (%)	N/A	N/A	DWS Full Width?	N/A
Surveyor Notes:			N/A	Landing Curb? (Y/N)	N/A	N/A	DWS Offset (in)	N/A
N/A			N/A	Shared Landing?	N/A			
PROW/ADA:			N/A	Gutter Ponding?	Yes	N/A	Gutter Slope (%)	N/A
Not Found, R304.2.2, R304.5.3			N/A	Gutter Lip Ht (in)	N/A	N/A	Gutter X Slope (%)	N/A

N/A	Painted X Walk1?	No	N/A	Painted X Walk2?	N/A
				X Walk 1 Direction	To SE		X Walk 2 Direction	N/A
			N/A	X Walk 1 Width (in)	N/A	N/A	X Walk 2 Width (in)	N/A
				X Walk 1 Slope (%)	6.2		X Walk 2 Slope (%)	N/A
				X Walk 1 X Slope (%)	3.1		X Walk 2 X Slope (%)	N/A
			N/A	Ramp inside XWalk1?	N/A	N/A	Ramp inside XWalk2?	N/A
				Road Slope (%)	N/A	N/A	Clear Space?	N/A
				Road X Slope (%)	N/A	N/A	Clear Space to XWalk (in)	N/A
			N/A	Any Obstructions?	N/A	N/A	Storm Grate/Utility Hazard?	N/A
				Obstruction Type			Storm Grate/Utility Type	
					N/A			N/A
						Yes	Surface Condition? (G/P)	Good
Total Cost:		\$ 1850.00
