Access Compliance Report

Public Rights-of-Way

(Curb Ramps)

Intersection ID: 30502	Main Street: ORCHARD_GRASS_CT	Cross Street: STONES_LANDING_ST	Location: NW
ADA ID: 3FFF9FB5F5CE	Ramp Type: PerpDiag	Initial Pass/Fail: Fail	Overall Compliance: No
Severity Score: 22.5			
Codes/Mitigation Info/Possible Solution		Field Measurements/Component Compliance

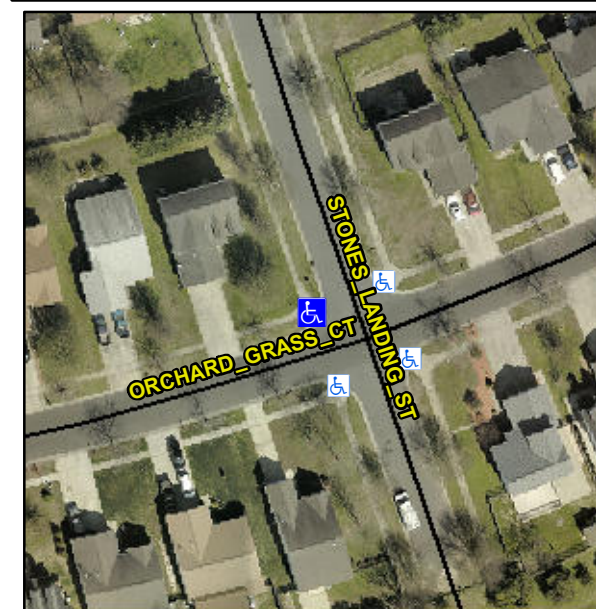
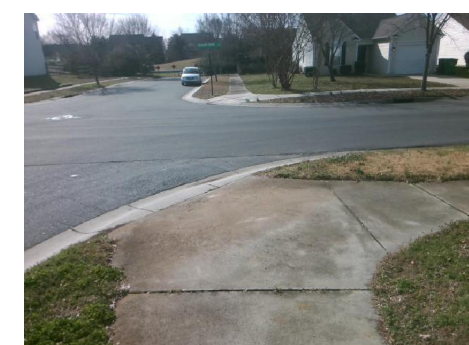
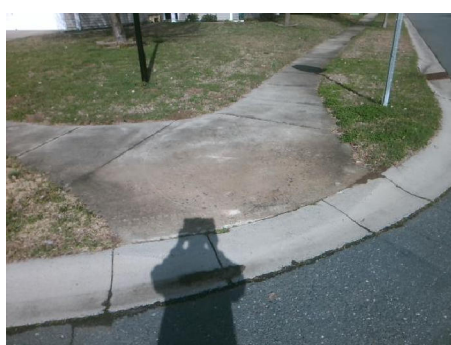
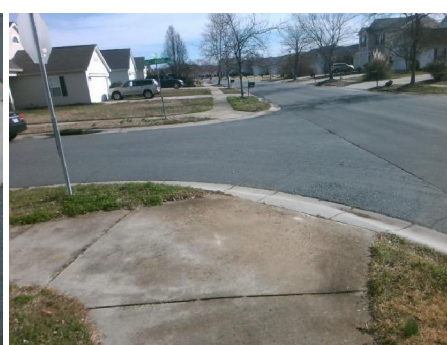
R304.5.1, R304.2.2, R304.5.3

Compliance	Description	Data	Compliance	Description	Data
N/A	Ramp Length (in)	118.0	No	Ramp Slope (%)	8.6
No	Ramp Width (in)	45.5	No	Ramp XSlope (%)	3.9
N/A	Flare Type LT	N/A	N/A	Flare Type RT	N/A
N/A	Flare Slope LT (%)	N/A	N/A	Flare Slope RT (%)	N/A
N/A	Flare Traversable LT?	N/A	N/A	Flare Traversable RT?	N/A
N/A	Landing Length (in)	N/A	N/A	DWS Provided?	N/A
N/A	Landing Width (in)	N/A	N/A	DWS Contrast?	N/A
N/A	Landing Slope (%)	N/A	N/A	DWS Length (in)	N/A
N/A	Landing X Slope (%)	N/A	N/A	DWS Full Width?	N/A
N/A	Landing Curb? (Y/N)	N/A	N/A	DWS Offset (in)	N/A
N/A	Shared Landing?	N/A			
N/A	Gutter Ponding?	N/A	N/A	Gutter Slope (%)	N/A
N/A	Gutter Lip Ht (in)	N/A	N/A	Gutter X Slope (%)	N/A
N/A	Painted X Walk1?	No	N/A	Painted X Walk2?	No
	X Walk 1 Direction	To S		X Walk 2 Direction	To E
N/A	X Walk 1 Width (in)	N/A	N/A	X Walk 2 Width (in)	N/A
	X Walk 1 Slope (%)	3.6		X Walk 2 Slope (%)	1.4
	X Walk 1 X Slope (%)	1.9		X Walk 2 X Slope (%)	0.9

N/A	Ramp inside XWalk1?	N/A	N/A	Ramp inside XWalk2?	N/A
	Road Slope (%)	1.6	N/A	Clear Space?	N/A
	Road X Slope (%)	0.8	N/A	Clear Space to XWalk (in)	N/A
N/A	Any Obstructions?	N/A	N/A	Storm Grate/Utility Hazard?	N/A
	Obstruction Type			Storm Grate/Utility Type	
		N/A			N/A
			Yes	Surface Condition? (G/P)	Good

Remove & Replace Curb Ramp With Two New Directional Ramps or Equivalent.
