# Access Compliance Report

## Public Rights-of-Way

### (Curb Ramps)

Intersection ID: 18210	Main Street: E_WOODLAWN_RD	Cross Street: BRANDYWINE_RD	Location: NE
ADA ID: 400CCF3ADCE4	Ramp Type: MedianPerp	Initial Pass/Fail: Fail	Overall Compliance: No
Severity Score: 25			
Codes/Mitigation Info/Possible Solution		Field Measurements/Component Compliance

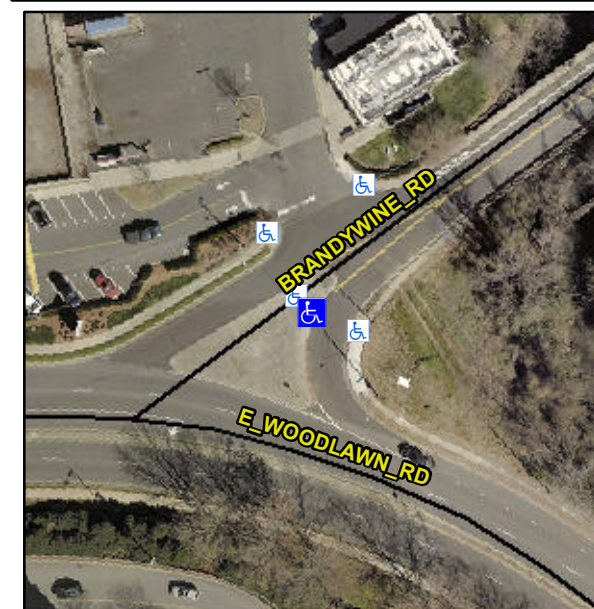
**Not Found, R304.2.2, R304.5.3**

Compliance	Description	Data	Compliance	Description	Data
N/A	Ramp Length (in)	57.0	No	Ramp Slope (%)	8.5
Yes	Ramp Width (in)	96.0	No	Ramp XSlope (%)	5.9
N/A	Flare Type LT	N/A	N/A	Flare Type RT	N/A
N/A	Flare Slope LT (%)	N/A	N/A	Flare Slope RT (%)	N/A
N/A	Flare Traversable LT?	N/A	N/A	Flare Traversable RT?	N/A
N/A	Landing Length (in)	N/A	N/A	DWS Provided?	N/A
N/A	Landing Width (in)	N/A	N/A	DWS Contrast?	N/A
N/A	Landing Slope (%)	N/A	N/A	DWS Length (in)	N/A
N/A	Landing X Slope (%)	N/A	N/A	DWS Full Width?	N/A
N/A	Landing Curb? (Y/N)	N/A	N/A	DWS Offset (in)	N/A
N/A	Shared Landing?	N/A			
N/A	Gutter Ponding?	N/A	N/A	Gutter Slope (%)	N/A
N/A	Gutter Lip Ht (in)	N/A	N/A	Gutter X Slope (%)	N/A
N/A	Painted X Walk1?	No	N/A	Painted X Walk2?	N/A
	X Walk 1 Direction	To SE		X Walk 2 Direction	N/A
N/A	X Walk 1 Width (in)	N/A	N/A	X Walk 2 Width (in)	N/A
	X Walk 1 Slope (%)	1.1		X Walk 2 Slope (%)	N/A
	X Walk 1 X Slope (%)	3.4		X Walk 2 X Slope (%)	N/A

N/A	Ramp inside XWalk1?	N/A	N/A	Ramp inside XWalk2?	N/A
	Road Slope (%)	N/A	N/A	Clear Space?	N/A
	Road X Slope (%)	N/A	N/A	Clear Space to XWalk (in)	N/A
N/A	Any Obstructions?	N/A	N/A	Storm Grate/Utility Hazard?	N/A
	Obstruction Type			Storm Grate/Utility Type	
		N/A			N/A
			Yes	Surface Condition? (G/P)	Good

**Remove & Replace Entire Ramp.**

Total Cost: \$ 1650.00
