Access Compliance Report

Public Rights-of-Way

(Curb Ramps)

Intersection ID: 10038380	Main Street: SOUTH_BV	Cross Street: N/A	Location: NE
ADA ID: 400DE55DE5E1	Ramp Type: Perp	Initial Pass/Fail: Fail	Overall Compliance: No
		Severity Score: 12.5	
Codes/Mitigation Info/Possible Solution		Field Measurements/Component Compliance

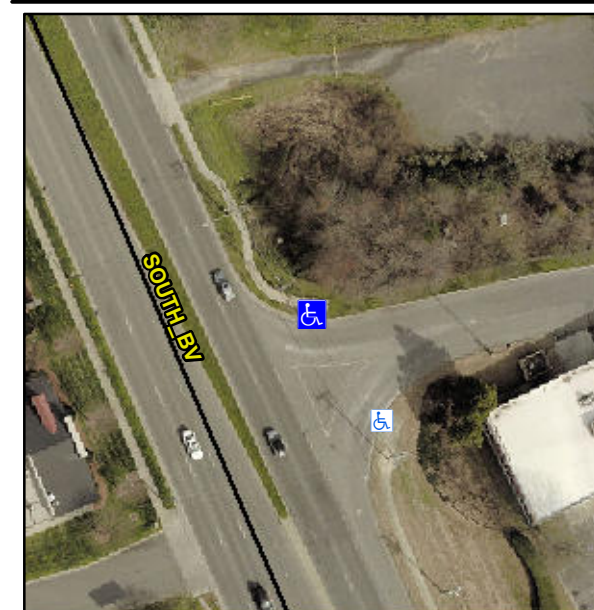
Not Found, R304.2.2

Compliance	Description	Data	Compliance	Description	Data
N/A	Ramp Length (in)	124.0	No	Ramp Slope (%)	11.2
Yes	Ramp Width (in)	48.0	Yes	Ramp XSlope (%)	1.1
N/A	Flare Type LT	N/A	N/A	Flare Type RT	N/A
N/A	Flare Slope LT (%)	N/A	N/A	Flare Slope RT (%)	N/A
N/A	Flare Traversable LT?	N/A	N/A	Flare Traversable RT?	N/A
N/A	Landing Length (in)	N/A	N/A	DWS Provided?	N/A
N/A	Landing Width (in)	N/A	N/A	DWS Contrast?	N/A
N/A	Landing Slope (%)	N/A	N/A	DWS Length (in)	N/A
N/A	Landing X Slope (%)	N/A	N/A	DWS Full Width?	N/A
N/A	Landing Curb? (Y/N)	N/A	N/A	DWS Offset (in)	N/A
N/A	Shared Landing?	N/A			
N/A	Gutter Ponding?	N/A	N/A	Gutter Slope (%)	N/A
N/A	Gutter Lip Ht (in)	N/A	N/A	Gutter X Slope (%)	N/A
N/A	Painted X Walk1?	No	N/A	Painted X Walk2?	N/A
	X Walk 1 Direction	To S		X Walk 2 Direction	N/A
N/A	X Walk 1 Width (in)	N/A	N/A	X Walk 2 Width (in)	N/A
	X Walk 1 Slope (%)	1.4		X Walk 2 Slope (%)	N/A
	X Walk 1 X Slope (%)	1.2		X Walk 2 X Slope (%)	N/A

Remove & Replace Entire Ramp.
