Access Compliance Report

Public Rights-of-Way

(Curb Ramps)

Intersection ID: 12792	Main Street: E_HILL_ST	Cross Street: S_TRYON_ST	Location: W
ADA ID: 40176EC1932D	Ramp Type: Perp	Initial Pass/Fail: Fail	Overall Compliance: No
Severity Score: 13.75			
Codes/Mitigation Info/Possible Solution		Field Measurements/Component Compliance

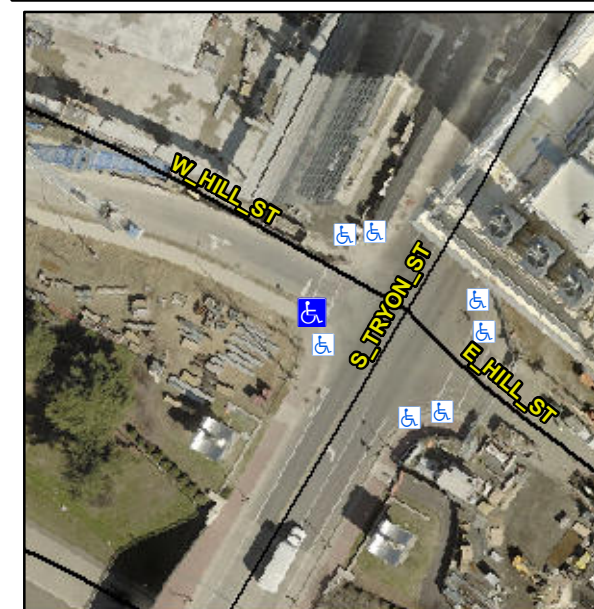
R304.2.2, R304.5.3

Compliance	Description	Data	Compliance	Description	Data
N/A	Ramp Length (in)	63.0	No	Ramp Slope (%)	9.3
Yes	Ramp Width (in)	60.0	No	Ramp XSlope (%)	4.7
N/A	Flare Type LT	N/A	N/A	Flare Type RT	N/A
N/A	Flare Slope LT (%)	N/A	N/A	Flare Slope RT (%)	N/A
N/A	Flare Traversable LT?	N/A	N/A	Flare Traversable RT?	N/A
N/A	Landing Length (in)	N/A	N/A	DWS Provided?	N/A
N/A	Landing Width (in)	N/A	N/A	DWS Contrast?	N/A
N/A	Landing Slope (%)	N/A	N/A	DWS Length (in)	N/A
N/A	Landing X Slope (%)	N/A	N/A	DWS Full Width?	N/A
N/A	Landing Curb? (Y/N)	N/A	N/A	DWS Offset (in)	N/A
N/A	Shared Landing?	N/A			
N/A	Gutter Ponding?	N/A	N/A	Gutter Slope (%)	N/A
N/A	Gutter Lip Ht (in)	N/A	N/A	Gutter X Slope (%)	N/A
N/A	Painted X Walk1?	Yes	N/A	Painted X Walk2?	N/A
	X Walk 1 Direction	To NE		X Walk 2 Direction	N/A
N/A	X Walk 1 Width (in)	112.0	N/A	X Walk 2 Width (in)	N/A
	X Walk 1 Slope (%)	0.5		X Walk 2 Slope (%)	N/A
	X Walk 1 X Slope (%)	3.4		X Walk 2 X Slope (%)	N/A

N/A	Ramp inside XWalk1?	Yes	N/A	Ramp inside XWalk2?	N/A
	Road Slope (%)	N/A	N/A	Clear Space?	N/A
	Road X Slope (%)	N/A	N/A	Clear Space to XWalk (in)	N/A
N/A	Any Obstructions?	N/A	N/A	Storm Grate/Utility Hazard?	N/A
	Obstruction Type			Storm Grate/Utility Type	
		N/A			N/A
		Yes		Surface Condition? (G/P)	Good

Remove & Replace Entire Ramp.
