Access Compliance Report

Public Rights-of-Way

(Curb Ramps)

Intersection ID: 14547	Main Street: EAST_BV	Cross Street: SPRINGDALE_AV	Location: SW
ADA ID: 40290422CE11	Ramp Type: Perp	Initial Pass/Fail: Fail	Overall Compliance: No
Severity Score: 13.75			
Codes/Mitigation Info/Possible Solution		Field Measurements/Component Compliance

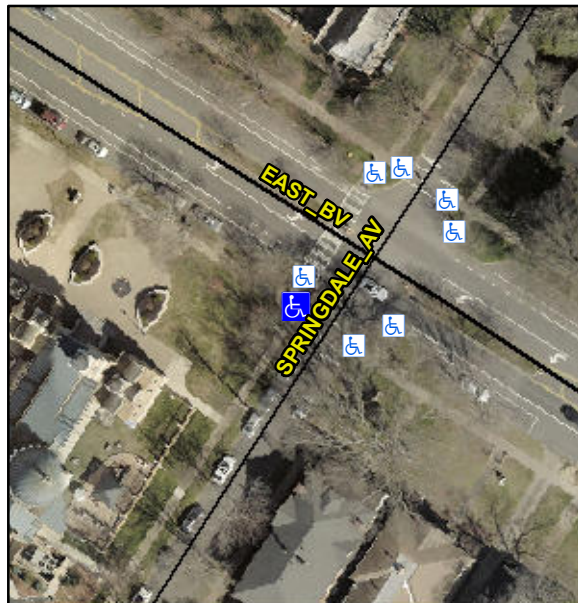
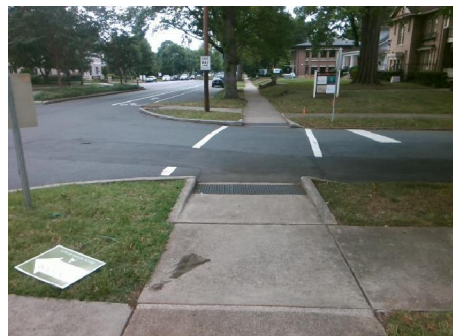
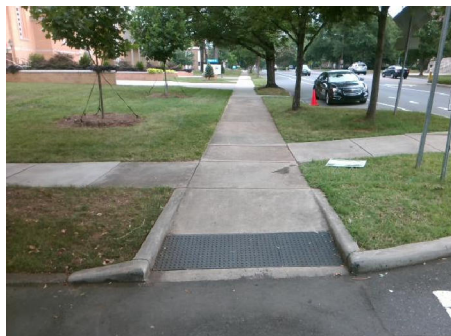
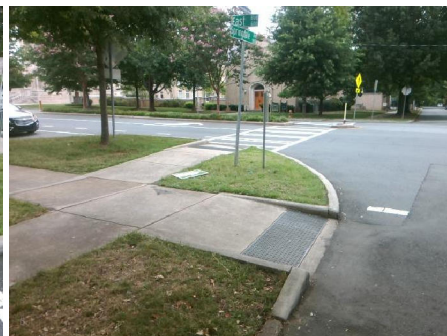
Not Found, R304.2.2, R304.5.3

Compliance	Description	Data	Compliance	Description	Data
N/A	Ramp Length (in)	83.0	No	Ramp Slope (%)	8.7
Yes	Ramp Width (in)	71.0	No	Ramp XSlope (%)	2.1
N/A	Flare Type LT	N/A	N/A	Flare Type RT	N/A
N/A	Flare Slope LT (%)	N/A	N/A	Flare Slope RT (%)	N/A
N/A	Flare Traversable LT?	N/A	N/A	Flare Traversable RT?	N/A
N/A	Landing Length (in)	N/A	N/A	DWS Provided?	N/A
N/A	Landing Width (in)	N/A	N/A	DWS Contrast?	N/A
N/A	Landing Slope (%)	N/A	N/A	DWS Length (in)	N/A
N/A	Landing X Slope (%)	N/A	N/A	DWS Full Width?	N/A
N/A	Landing Curb? (Y/N)	N/A	N/A	DWS Offset (in)	N/A
N/A	Shared Landing?	N/A			
N/A	Gutter Ponding?	N/A	N/A	Gutter Slope (%)	N/A
N/A	Gutter Lip Ht (in)	N/A	N/A	Gutter X Slope (%)	N/A
N/A	Painted X Walk1?	Yes	N/A	Painted X Walk2?	N/A
	X Walk 1 Direction	To SE		X Walk 2 Direction	N/A
N/A	X Walk 1 Width (in)	112.0	N/A	X Walk 2 Width (in)	N/A
	X Walk 1 Slope (%)	0.9		X Walk 2 Slope (%)	N/A
	X Walk 1 X Slope (%)	1.4		X Walk 2 X Slope (%)	N/A

N/A	Ramp inside XWalk1?	Yes	N/A	Ramp inside XWalk2?	N/A
	Road Slope (%)	N/A	N/A	Clear Space?	N/A
	Road X Slope (%)	N/A	N/A	Clear Space to XWalk (in)	N/A
N/A	Any Obstructions?	N/A	N/A	Storm Grate/Utility Hazard?	N/A
	Obstruction Type			Storm Grate/Utility Type	
		N/A			N/A
		Yes		Surface Condition? (G/P)	Good

Remove & Replace Entire Ramp.
