Access Compliance Report

Public Rights-of-Way

(Curb Ramps)

Intersection ID: N/A	Main Street: SOUTHMORE_DR	Cross Street: HOUSTON_FIELD_CT	Location: SW
ADA ID: 404B7FE85860	Ramp Type: PerpDiag	Initial Pass/Fail: Fail	Overall Compliance: No
			Severity Score: 13.75

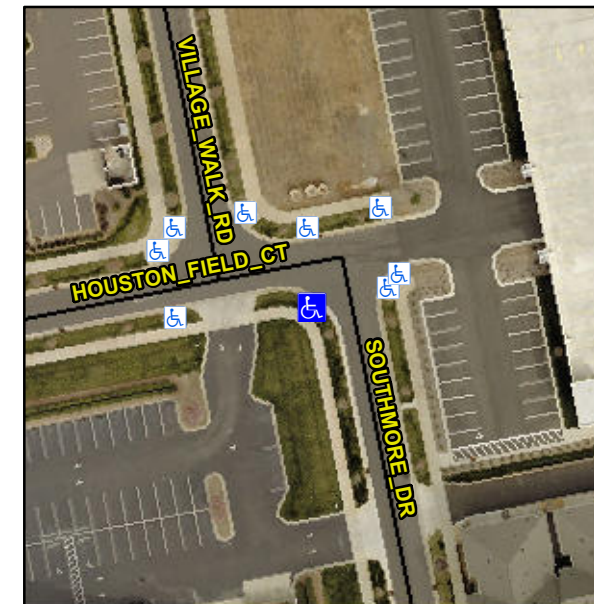
Not Found, R304.2.2, R304.5.3

Compliance	Description	Data	Compliance	Description	Data
N/A	Ramp Length (in)	96.0	No	Ramp Slope (%)	9.8
Yes	Ramp Width (in)	65.0	No	Ramp XSlope (%)	2.6
N/A	Flare Type LT	N/A	N/A	Flare Type RT	N/A
N/A	Flare Slope LT (%)	N/A	N/A	Flare Slope RT (%)	N/A
N/A	Flare Traversable LT?	N/A	N/A	Flare Traversable RT?	N/A
N/A	Landing Length (in)	N/A	N/A	DWS Provided?	N/A
N/A	Landing Width (in)	N/A	N/A	DWS Contrast?	N/A
N/A	Landing Slope (%)	N/A	N/A	DWS Length (in)	N/A
N/A	Landing X Slope (%)	N/A	N/A	DWS Full Width?	N/A
N/A	Landing Curb? (Y/N)	N/A	N/A	DWS Offset (in)	N/A
N/A	Shared Landing?	N/A			
N/A	Gutter Ponding?	N/A	N/A	Gutter Slope (%)	N/A
N/A	Gutter Lip Ht (in)	N/A	N/A	Gutter X Slope (%)	N/A
N/A	Painted X Walk1?	No	N/A	Painted X Walk2?	No
	X Walk 1 Direction	To E		X Walk 2 Direction	To N
N/A	X Walk 1 Width (in)	N/A	N/A	X Walk 2 Width (in)	N/A
	X Walk 1 Slope (%)	4.8		X Walk 2 Slope (%)	2.1
	X Walk 1 X Slope (%)	0.4		X Walk 2 X Slope (%)	5.2

N/A	Ramp inside XWalk1?	N/A	N/A	Ramp inside XWalk2?	N/A
	Road Slope (%)	2.1	N/A	Clear Space?	N/A
	Road X Slope (%)	7.5	N/A	Clear Space to XWalk (in)	N/A
N/A	Any Obstructions?	N/A	N/A	Storm Grate/Utility Hazard?	N/A
	Obstruction Type			Storm Grate/Utility Type	
		N/A			N/A
		Yes		Surface Condition? (G/P)	Good

Remove & Replace Curb Ramp With Two New Directional Ramps or Equivalent.
