# Access Compliance Report

## Public Rights-of-Way

### (Curb Ramps)

Intersection ID: 47442	Main Street: OROFINO_CT	Cross Street: KALISPELL_LN	Location: NW
ADA ID: 404DB77074C7	Ramp Type: PerpDiag	Initial Pass/Fail: Fail	Overall Compliance: No
Severity Score: 33.75			
Codes/Mitigation Info/Possible Solution		Field Measurements/Component Compliance

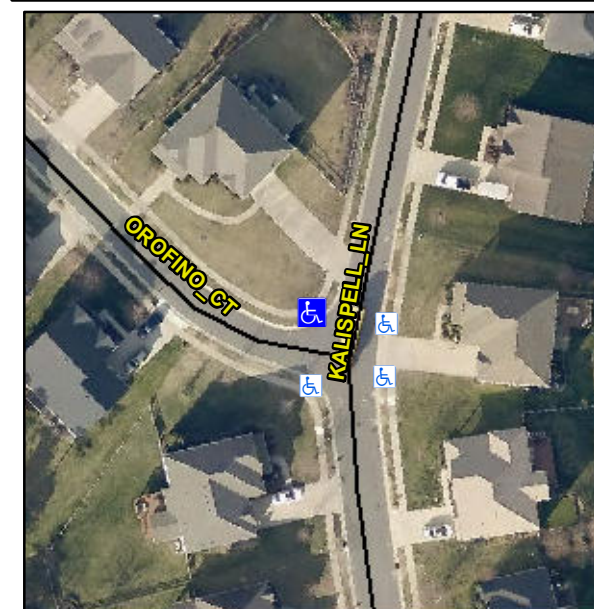
Compliance	Description	Data	Compliance	Description	Data
N/A	Ramp Length (in)	48.0	Yes	Ramp Slope (%)	8.0
No	Ramp Width (in)	47.0	No	Ramp XSlope (%)	7.6
N/A	Flare Type LT	N/A	N/A	Flare Type RT	N/A
N/A	Flare Slope LT (%)	N/A	N/A	Flare Slope RT (%)	N/A
N/A	Flare Traversable LT?	N/A	N/A	Flare Traversable RT?	N/A
N/A	Landing Length (in)	N/A	N/A	DWS Provided?	N/A
N/A	Landing Width (in)	N/A	N/A	DWS Contrast?	N/A
N/A	Landing Slope (%)	N/A	N/A	DWS Length (in)	N/A
N/A	Landing X Slope (%)	N/A	N/A	DWS Full Width?	N/A
N/A	Landing Curb? (Y/N)	N/A	N/A	DWS Offset (in)	N/A
N/A	Shared Landing?	N/A			
N/A	Gutter Ponding?	N/A	N/A	Gutter Slope (%)	N/A
N/A	Gutter Lip Ht (in)	N/A	N/A	Gutter X Slope (%)	N/A
N/A	Painted X Walk1?	No	N/A	Painted X Walk2?	No
	X Walk 1 Direction	To S		X Walk 2 Direction	To E
N/A	X Walk 1 Width (in)	N/A	N/A	X Walk 2 Width (in)	N/A
	X Walk 1 Slope (%)	13.0		X Walk 2 Slope (%)	0.1
	X Walk 1 X Slope (%)	2.0		X Walk 2 X Slope (%)	10.9

N/A	Ramp inside XWalk1?	N/A	N/A	Ramp inside XWalk2?	N/A
	Road Slope (%)	6.4	N/A	Clear Space?	N/A
	Road X Slope (%)	12.7	N/A	Clear Space to XWalk (in)	N/A
N/A	Any Obstructions?	N/A	N/A	Storm Grate/Utility Hazard?	N/A
	Obstruction Type			Storm Grate/Utility Type	
		N/A			N/A
		Yes		Surface Condition? (G/P)	Good

**Remove & Replace Curb Ramp With Two New Directional Ramps or Equivalent.**

**R304.5.1, R304.5.3**
