# Access Compliance Report

## Public Rights-of-Way

### (Curb Ramps)

| Intersection ID: N/A | Main Street: BEVINGTON_PL | Cross Street: PEMBRY_LINKS_CR | Location: NE |

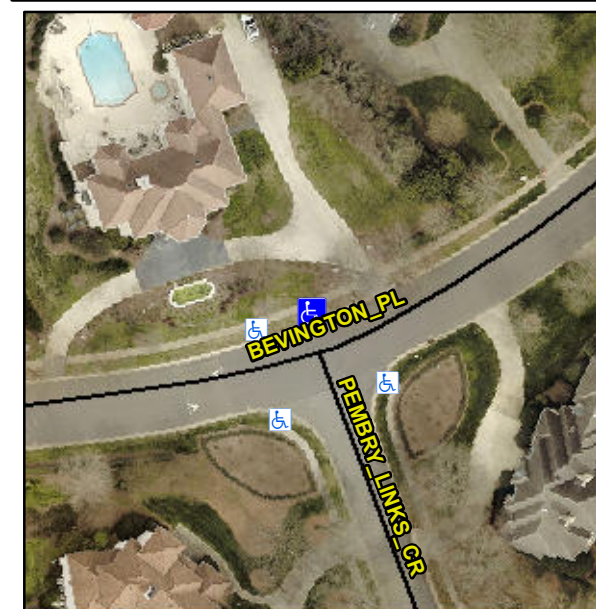
| ADA ID: 404F388A12EE | Ramp Type: Perp | Initial Pass/Fail: Pass | Overall Compliance: No |

**Not Found, R304.5.3, R304.2.1,  
R304.2.2-Perp, R304.3.2-Para**

| Compliance | Description | Data | Compliance | Description | Data |
|---|---|---|---|---|---|
| N/A | Ramp Length (in) | 121.0 | Yes | Ramp Slope (%) | 5.3 |
| Yes | Ramp Width (in) | 49.0 | No | Ramp XSlope (%) | 4.3 |
| No | Landing Length (in) | N/A | Yes | DWS Provided? | Yes |
| No | Landing Width (in) | N/A | Yes | DWS Contrast? | Yes |
| No | Landing Slope (%) | N/A | Yes | DWS Length (in) | 25.0 |
| No | Landing X Slope (%) | N/A | Yes | DWS Full Width? | Yes |
| Yes | Gutter Lip Ht (in) | 0.0 | No | Gutter X Slope (%) | 3.7 |

**Remove & Replace Entire Ramp.  
Remove & Replace Gutter.**

Total Cost: \$ 2600.00
