Access Compliance Report

Public Rights-of-Way

(Curb Ramps)

Intersection ID: 46481	Main Street: REVENNA_LN	Cross Street: BERKELEY_PLACE_DR	Location:	N
ADA ID: 40507E20D354	Ramp Type: PerpDiag	Initial Pass/Fail: Fail	Overall Compliance: No	Severity Score: 25

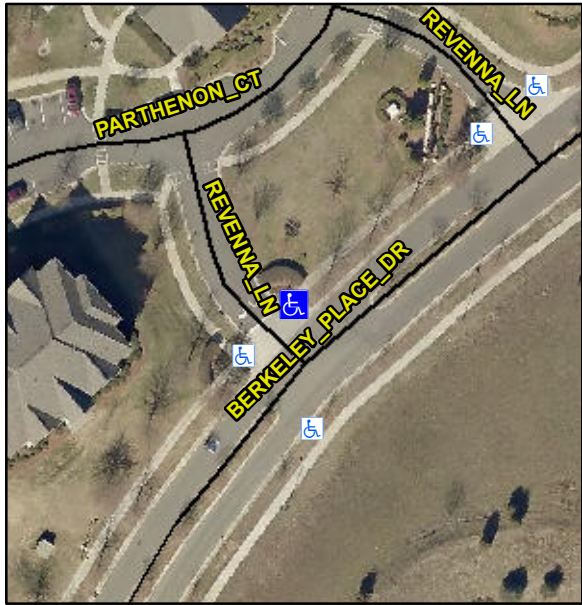
<div>Street 1 NameREVENNA LNDivStop Condition-Street 2StopSignDivStreet 2 NameBERKELEY DRDivStop Condition-Street 1None</div>	Possible Solutions:		Compliance	Description	Data	Compliance	Description	Data
	Remove & Replace Curb Ramp With Two New Directional Ramps or Equivalent.		N/A	Ramp Length (in)	85.0	No	Ramp Slope (%)	20.0
			Yes	Ramp Width (in)	48.0	Yes	Ramp XSlope (%)	0.6
			N/A	Flare Type LT	N/A	N/A	Flare Type RT	N/A
			N/A	Flare Slope LT (%)	N/A	N/A	Flare Slope RT (%)	N/A
			N/A	Flare Traversable LT?	N/A	N/A	Flare Traversable RT?	N/A
			N/A	Landing Length (in)	N/A	N/A	DWS Provided?	N/A
			N/A	Landing Width (in)	N/A	N/A	DWS Contrast?	N/A
			N/A	Landing Slope (%)	N/A	N/A	DWS Length (in)	N/A
			N/A	Landing X Slope (%)	N/A	N/A	DWS Full Width?	N/A
			N/A	Landing Curb? (Y/N)	N/A	N/A	DWS Offset (in)	N/A
			N/A	Shared Landing?	N/A
