Access Compliance Report Public Rights-of-Way (Curb Ramps)

Main Street: BRIARWICK_LN Intersection ID: 10021759 **Cross Street: N/A** Location: SE ADA ID: 405B89CA0239 Ramp Type: Perp Initial Pass/Fail: Fail **Overall Compliance: No Severity Score:** 12.5

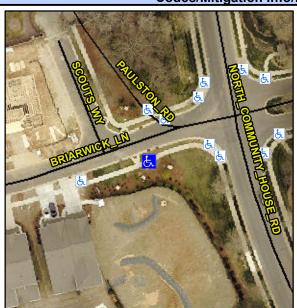
BRIARWICK LN Street 1 Name Stop Condition-Street 2 None Street 2 Name N/A Stop Condition-Street 1 N/A Possible Solutions: Remove & Replace Entire Ramp. Surveyor Notes: N/A PROW/ADA: Not Found, R304.5.3

| Field Measurements/Component Compliance | | | | | | |
|---|---|---|---|---|---|---|
| Yes | Ramp Width (in) | 59.0 | No | Ram | xSlope (%) | 5.4 |
