Access Compliance Report

Public Rights-of-Way

(Curb Ramps)

Intersection ID: 11058	Main Street: N I-77 EXIT 10B RA	Cross Street: N I-77 EXIT 10C RA	Location: SW
ADA ID: 406368B56BED	Ramp Type: Combination1	Initial Pass/Fail: Fail	Overall Compliance: No
			Severity Score: 13.75

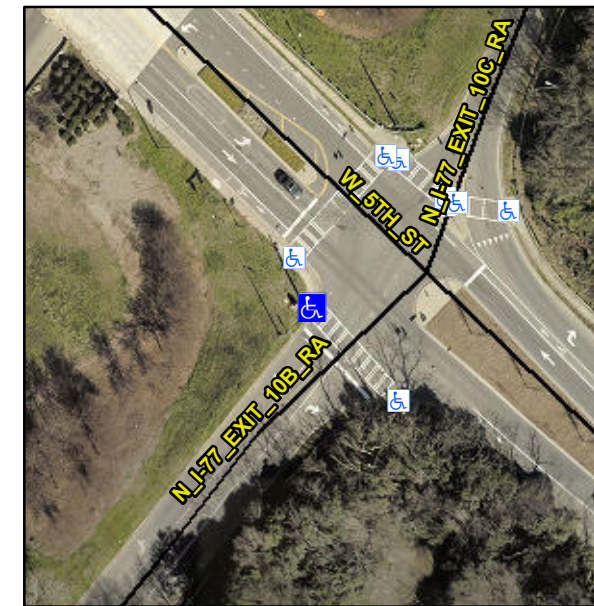
RP & LT RP < 5%

Not Found, R304.5.3, R304.3.2

Compliance	Description	Data	Compliance	Description	Data
N/A	Ramp Length LT (in)	61.0	N/A	Ramp Length RT (in)	33.0
Yes	Ramp Width LT (in)	67.0	Yes	Ramp Width RT (in)	72.0
Yes	Ramp Slope LT (%)	1.6	No	Ramp Slope RT (%)	9.9
No	Ramp XSlope LT (%)	4.1	Yes	Ramp XSlope RT (%)	1.2
N/A	Ramp Length (in)	26.0	Yes	Ramp Slope (%)	5.3
Yes	Ramp Width (in)	48.0	Yes	Ramp XSlope (%)	3.3
N/A	Flare Type LT	N/A	N/A	Flare Type RT	N/A
N/A	Flare Slope LT (%)	N/A	N/A	Flare Slope RT (%)	N/A
N/A	Flare Traversable LT?	N/A	N/A	Flare Traversable RT?	N/A
N/A	Landing Length (in)	N/A	N/A	DWS Provided?	N/A
N/A	Landing Width (in)	N/A	N/A	DWS Contrast?	N/A
N/A	Landing Slope (%)	N/A	N/A	DWS Length (in)	N/A
N/A	Landing X Slope (%)	N/A	N/A	DWS Full Width?	N/A
N/A	Landing Curb? (Y/N)	N/A	N/A	DWS Offset (in)	N/A
N/A	Shared Landing?	N/A			
N/A	Gutter Ponding?	N/A	N/A	Gutter Slope (%)	N/A
N/A	Gutter Lip Ht (in)	N/A	N/A	Gutter X Slope (%)	N/A
N/A	Painted X Walk1?	Yes	N/A	Painted X Walk2?	N/A

X Walk 1 Direction	To SE		X Walk 2 Direction	N/A
	X Walk 1 Width (in)	113.0		X Walk 2 Width (in)	N/A
	X Walk 1 Slope (%)	0.5		X Walk 2 Slope (%)	N/A
	X Walk 1 X Slope (%)	3.6		X Walk 2 X Slope (%)	N/A
N/A	Ramp inside XWalk1?	Yes	N/A	Ramp inside XWalk2?	N/A
	Road Slope (%)	N/A		Clear Space?	N/A
	Road X Slope (%)	N/A	N/A	Clear Space to XWalk (in)	N/A
			N/A	Any Obstruction?	N/A
				Obstruction Type	N/A
			N/A	Storm Grate/Utility Hazard?	N/A
				Storm Grate/Utility Type	N/A
					N/A
Yes	Surface Condition? (G/P)	Good			
	Curb Slope (%)	15.6

**Remove & Replace Entire Ramp.
Remove & Replace Sidewalk.**
