# Access Compliance Report

## Public Rights-of-Way

### (Curb Ramps)

Intersection ID: 17285	Main Street: SHARON_RD	Cross Street: WESTMINSTER_PL	Location: SE
ADA ID: 406646230DF9	Ramp Type: BlendTrans1	Initial Pass/Fail: Fail	Overall Compliance: No
Severity Score: 1.25			
Codes/Mitigation Info/Possible Solution		Field Measurements/Component Compliance

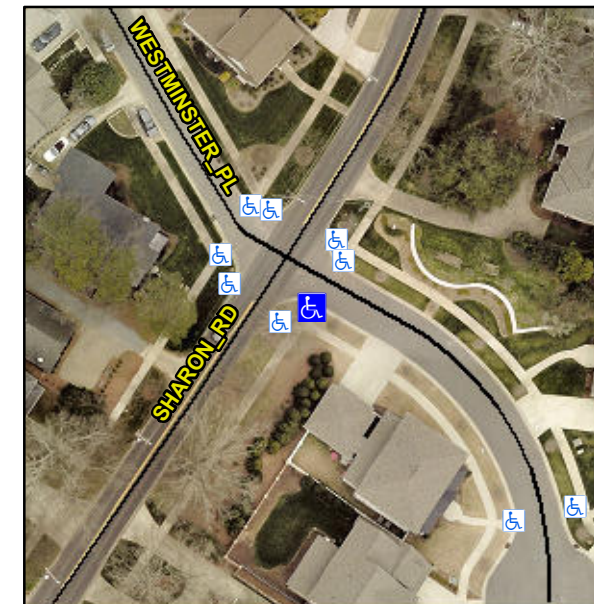
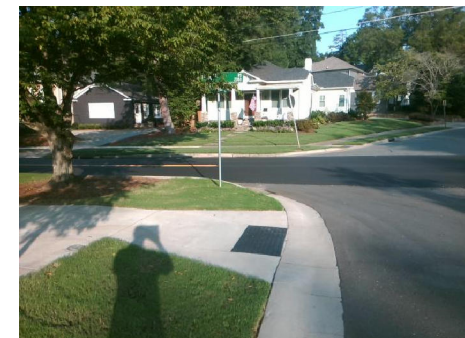
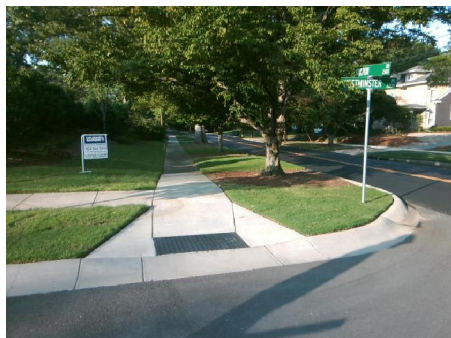
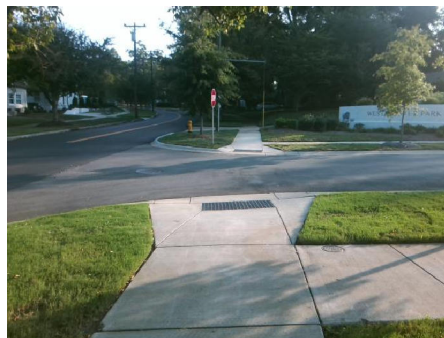
Compliance	Description	Data	Compliance	Description	Data
N/A	Ramp Length (in)	83.0	Yes	BlendTrans Slope (%)	2.3
Yes	Ramp Width (in)	48.0	No	BlendTrans XSlope (%)	3.7
N/A	Flare Type LT	N/A	N/A	Flare Type RT	N/A
N/A	Flare Slope LT (%)	N/A	N/A	Flare Slope RT (%)	N/A
N/A	Flare Traversable LT?	N/A	N/A	Flare Traversable RT?	N/A
N/A	Landing Length (in)	N/A	N/A	DWS Provided?	N/A
N/A	Landing Width (in)	N/A	N/A	DWS Contrast?	N/A
N/A	Landing Slope (%)	N/A	N/A	DWS Length (in)	N/A
N/A	Landing X Slope (%)	N/A	N/A	DWS Full Width?	N/A
N/A	Landing Curb? (Y/N)	N/A	N/A	DWS Offset (in)	N/A
N/A	Shared Landing?	N/A			
N/A	Gutter Ponding?	N/A	N/A	Gutter Slope (%)	N/A
N/A	Gutter Lip Ht (in)	N/A	N/A	Gutter X Slope (%)	N/A
N/A	Painted X Walk1?	No	N/A	Painted X Walk2?	N/A
	X Walk 1 Direction	To NE		X Walk 2 Direction	N/A
	X Walk 1 Width (in)	N/A		X Walk 2 Width (in)	N/A
	X Walk 1 Slope (%)	1.1		X Walk 2 Slope (%)	N/A
	X Walk 1 X Slope (%)	4.3		X Walk 2 X Slope (%)	N/A

N/A	Ramp inside XWalk1?	N/A	N/A	Ramp inside XWalk2?	N/A
	Road Slope (%)	4.3		Clear Space?	N/A
	Road X Slope (%)	1.1	N/A	Clear Space to XWalk (in)	N/A
N/A	Any Obstructions?	N/A	N/A	Storm Grate/Utility Hazard?	N/A
	Obstruction Type			Storm Grate/Utility Type	
		N/A			N/A
			Yes	Surface Condition? (G/P)	Good
			N/A	Curb Slope (%)	4.3

**Remove & Replace Curb Ramp With Two New Directional Ramps or Equivalent.**

**R304.5.3**

Total Cost: \$ 3200.00
