Access Compliance Report

Public Rights-of-Way

(Curb Ramps)

Intersection ID: 49698	Main Street: LOUGHLIN_LN	Cross Street: MADISON_HILL_CT	Location: E
ADA ID: 40910A40BF08	Ramp Type: PerpDiag	Initial Pass/Fail: Fail	Overall Compliance: No
Severity Score: 12.5			
Codes/Mitigation Info/Possible Solution		Field Measurements/Component Compliance

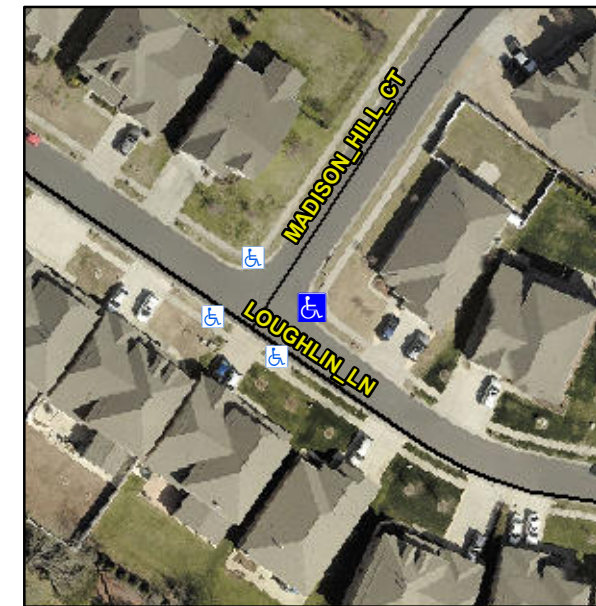
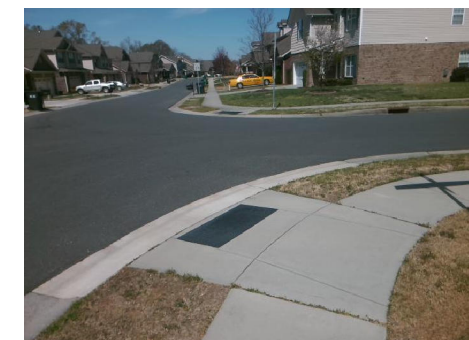
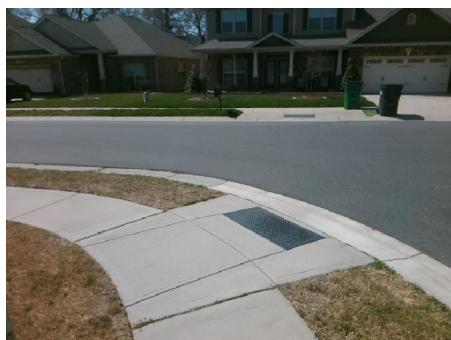
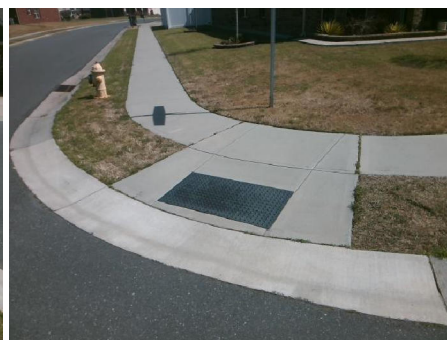
Not Found, R304.2.2

Compliance	Description	Data	Compliance	Description	Data
N/A	Ramp Length (in)	47.0	No	Ramp Slope (%)	10.5
Yes	Ramp Width (in)	48.0	Yes	Ramp XSlope (%)	1.3
N/A	Flare Type LT	N/A	N/A	Flare Type RT	N/A
N/A	Flare Slope LT (%)	N/A	N/A	Flare Slope RT (%)	N/A
N/A	Flare Traversable LT?	N/A	N/A	Flare Traversable RT?	N/A
N/A	Landing Length (in)	N/A	N/A	DWS Provided?	N/A
N/A	Landing Width (in)	N/A	N/A	DWS Contrast?	N/A
N/A	Landing Slope (%)	N/A	N/A	DWS Length (in)	N/A
N/A	Landing X Slope (%)	N/A	N/A	DWS Full Width?	N/A
N/A	Landing Curb? (Y/N)	N/A	N/A	DWS Offset (in)	N/A
N/A	Shared Landing?	N/A			
N/A	Gutter Ponding?	N/A	N/A	Gutter Slope (%)	N/A
N/A	Gutter Lip Ht (in)	N/A	N/A	Gutter X Slope (%)	N/A
N/A	Painted X Walk1?	No	N/A	Painted X Walk2?	No
	X Walk 1 Direction	To NW		X Walk 2 Direction	To SW
N/A	X Walk 1 Width (in)	N/A	N/A	X Walk 2 Width (in)	N/A
	X Walk 1 Slope (%)	2.5		X Walk 2 Slope (%)	0.0
	X Walk 1 X Slope (%)	0.0		X Walk 2 X Slope (%)	1.8

N/A	Ramp inside XWalk1?	N/A	N/A	Ramp inside XWalk2?	N/A
	Road Slope (%)	2.3	N/A	Clear Space?	N/A
	Road X Slope (%)	3.5	N/A	Clear Space to XWalk (in)	N/A
N/A	Any Obstructions?	N/A	N/A	Storm Grate/Utility Hazard?	N/A
	Obstruction Type			Storm Grate/Utility Type	
		N/A			N/A
			Yes	Surface Condition? (G/P)	Good

Remove & Replace Curb Ramp With Two New Directional Ramps or Equivalent.
