# Access Compliance Report

## Public Rights-of-Way

### (Curb Ramps)

| Intersection ID: 45984 | Main Street: CHESTERBROOK_LN | Cross Street: MASON MILL_PL | Location: SE |

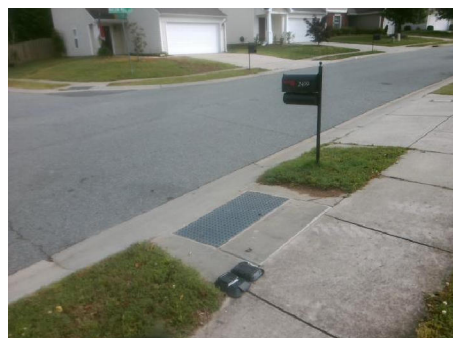
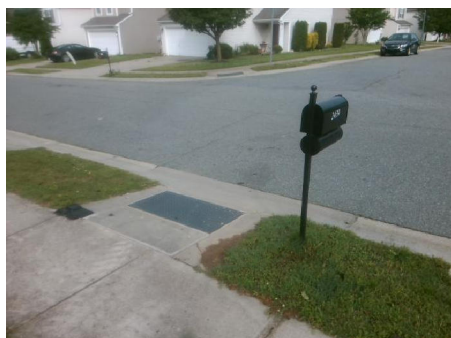
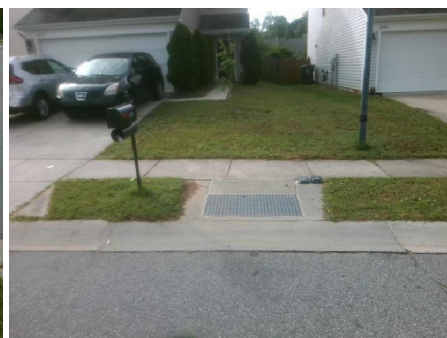
| ADA ID: 4093F880E7FA | Ramp Type: Perp | Initial Pass/Fail: Fail | Overall Compliance: No |
| Severity Score: 26.25 | | | |

**Not Found, R304.2.2, R304.5.3**

| Compliance | Description | Data | Compliance | Description | Data |
|---|---|---|---|---|---|
| N/A | Ramp Length (in) | 48.0 | No | Ramp Slope (%) | 12.5 |
| Yes | Ramp Width (in) | 48.0 | No | Ramp XSlope (%) | 4.4 |

**Remove & Replace Entire Ramp.**

Total Cost: \$ 1850.00
