Access Compliance Report

Public Rights-of-Way

(Curb Ramps)

Intersection ID: 8231	Main Street: CINDERELLA_RD	Cross Street: MUNSEE_ST	Location:	W
ADA ID: 40A1DE4912D9	Ramp Type: Perp	Initial Pass/Fail: Fail	Overall Compliance: No	Severity Score: 8.75

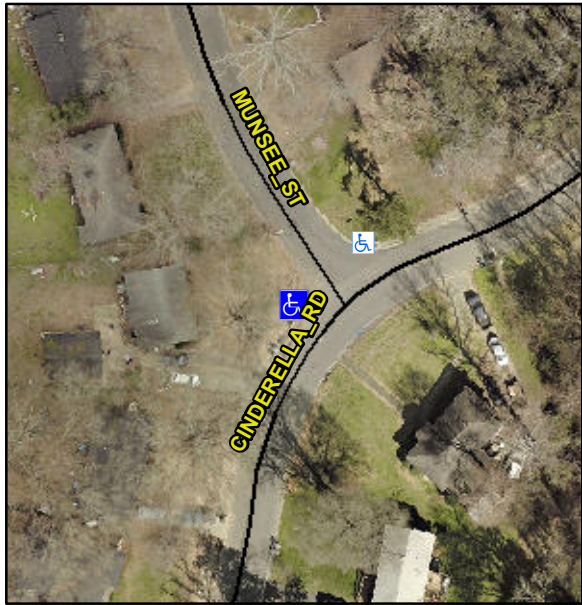
Possible Solutions:		Remove & Replace Entire Ramp.					
	Surveyor Notes:		N/A					
	PROW/ADA:		Not Found, R304.5.1					
	Total Cost:		\$ 1850.00					
	Street 1 Name		MUNSEE ST					
	Stop Condition-Street 2		StopSign					
	Street 2 Name		N/A					
	Stop Condition-Street 1		N/A					
			Compliance	Description	Data	Compliance	Description	Data
			N/A	Ramp Length (in)	47.0	Yes	Ramp Slope (%)	6.6
			No	Ramp Width (in)	47.5	Yes	Ramp XSlope (%)	1.7
			N/A	Flare Type LT	N/A	N/A	Flare Type RT	N/A
			N/A	Flare Slope LT (%)	N/A	N/A	Flare Slope RT (%)	N/A
			N/A	Flare Traversable LT?	N/A	N/A	Flare Traversable RT?	N/A
			N/A	Landing Length (in)	N/A	N/A	DWS Provided?	N/A
			N/A	Landing Width (in)	N/A	N/A	DWS Contrast?	N/A
			N/A	Landing Slope (%)	N/A	N/A	DWS Length (in)	N/A
			N/A	Landing X Slope (%)	N/A	N/A	DWS Full Width?	N/A
			N/A	Landing Curb? (Y/N)	N/A	N/A	DWS Offset (in)	N/A

N/A	Shared Landing?	N/A			
			N/A	Gutter Ponding?	N/A	N/A	Gutter Slope (%)	N/A
			N/A	Gutter Lip Ht (in)	1.0	N/A	Gutter X Slope (%)	N/A
			N/A	Painted X Walk1?	No	N/A	Painted X Walk2?	N/A
				X Walk 1 Direction	To NE		X Walk 2 Direction	N/A
			N/A	X Walk 1 Width (in)	N/A	N/A	X Walk 2 Width (in)	N/A
				X Walk 1 Slope (%)	2.5		X Walk 2 Slope (%)	N/A
				X Walk 1 X Slope (%)	2.4		X Walk 2 X Slope (%)	N/A
			N/A	Ramp inside XWalk1?	N/A	N/A	Ramp inside XWalk2?	N/A
				Road Slope (%)	N/A	N/A	Clear Space?	N/A
				Road X Slope (%)	N/A	N/A	Clear Space to XWalk (in)	N/A
			N/A	Any Obstructions?	N/A	N/A	Storm Grate/Utility Hazard?	N/A
				Obstruction Type			Storm Grate/Utility Type	
					N/A			N/A
						Yes	Surface Condition? (G/P)	Good
