# Access Compliance Report

## Public Rights-of-Way

### (Curb Ramps)

Intersection ID: 5823	Main Street: FOSTER_BROOK_DR	Cross Street: HIPPI_RD	Location:	N/A
ADA ID: 40ADDC4DB9C5	Ramp Type: BlendTrans2	Initial Pass/Fail: Fail	Overall Compliance: No	Severity Score: 35
Codes/Mitigation Info/Possible Solution		Field Measurements/Component Compliance

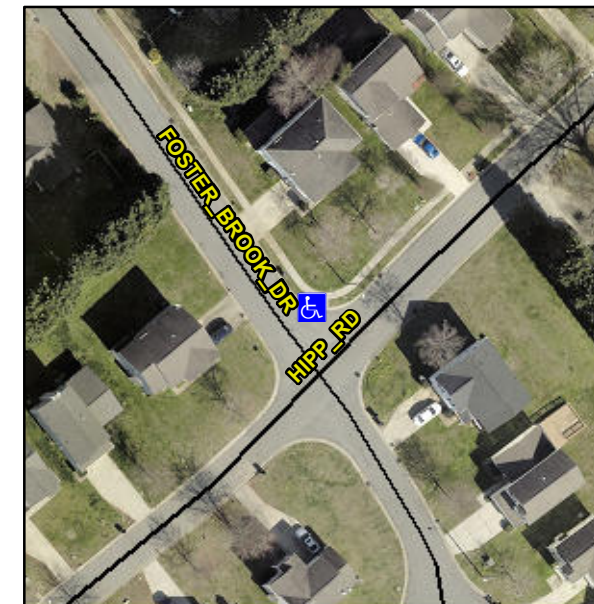
**Not Found, R304.5.1**

Compliance	Description	Data	Compliance	Description	Data
N/A	Ramp Length (in)	96.0	Yes	BlendTrans Slope (%)	0.9
No	Ramp Width (in)	31.0	Yes	BlendTrans XSlope (%)	1.1
N/A	Flare Type LT	N/A	N/A	Flare Type RT	N/A
N/A	Flare Slope LT (%)	N/A	N/A	Flare Slope RT (%)	N/A
N/A	Flare Traversable LT?	N/A	N/A	Flare Traversable RT?	N/A
N/A	Landing Length (in)	N/A	N/A	DWS Provided?	N/A
N/A	Landing Width (in)	N/A	N/A	DWS Contrast?	N/A
N/A	Landing Slope (%)	N/A	N/A	DWS Length (in)	N/A
N/A	Landing X Slope (%)	N/A	N/A	DWS Full Width?	N/A
N/A	Landing Curb? (Y/N)	N/A	N/A	DWS Offset (in)	N/A
N/A	Shared Landing?	N/A			
N/A	Gutter Ponding?	N/A	N/A	Gutter Slope (%)	N/A
N/A	Gutter Lip Ht (in)	N/A	N/A	Gutter X Slope (%)	N/A
N/A	Painted X Walk1?	No	N/A	Painted X Walk2?	No
	X Walk 1 Direction	To SW		X Walk 2 Direction	To SE
	X Walk 1 Width (in)	N/A		X Walk 2 Width (in)	N/A
	X Walk 1 Slope (%)	1.9		X Walk 2 Slope (%)	N/A
	X Walk 1 X Slope (%)	1.1		X Walk 2 X Slope (%)	N/A

N/A	Ramp inside XWalk1?	N/A	N/A	Ramp inside XWalk2?	N/A
	Road Slope (%)	1.1		Clear Space?	N/A
	Road X Slope (%)	1.9	N/A	Clear Space to XWalk (in)	N/A
N/A	Any Obstructions?	N/A	N/A	Storm Grate/Utility Hazard?	N/A
	Obstruction Type			Storm Grate/Utility Type	
		N/A			N/A
			Yes	Surface Condition? (G/P)	Good
			No	Curb Slope (%)	8.4

**Remove & Replace Curb Ramp With Two New Directional Ramps or Equivalent.**
