# Access Compliance Report

## Public Rights-of-Way (Curb Ramps)

| Intersection ID: 13846 | Main Street: CAMDEN_RD | Cross Street: W_KINGSTON_AV | Location: | N |
| ADA ID: 40AFAF1B1391 | Ramp Type: Directional1 | Initial Pass/Fail: Pass | Overall Compliance: No | Severity Score: 5 |

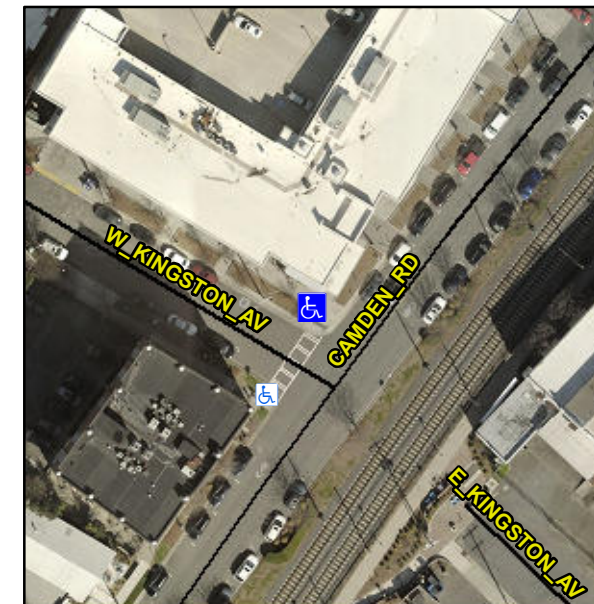
**R304.2.3**

| Compliance | Description | Data | Compliance | Description | Data |
|---|---|---|---|---|---|
| No | Flare Type LT | N/A | No | Flare Type RT | N/A |

**Remove & Replace Entire Ramp.**

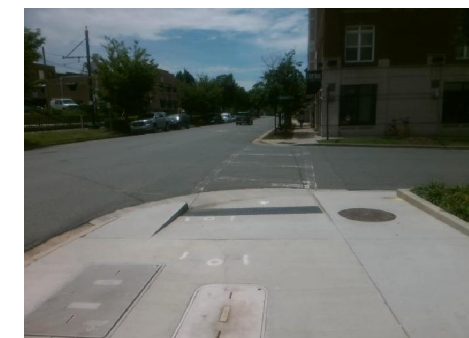
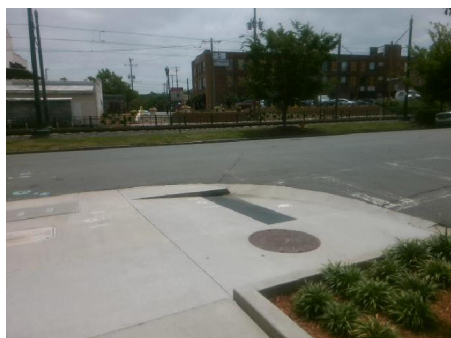
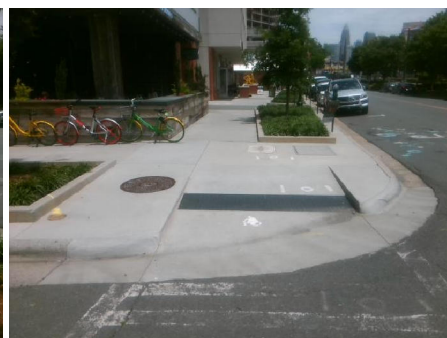
| Compliance | Description | Data | Compliance | Description | Data |
|---|---|---|---|---|---|
| | X Walk 1 X Slope (%) | 4.0 | Yes | Storm Grate/Utility Hazard? | No |
