Access Compliance Report

Public Rights-of-Way

(Curb Ramps)

Intersection ID: 3298	Main Street: INGLETON_CT	Cross Street: MCKENDREE_WY	Location: NW
ADA ID: 40BB79CB84C6	Ramp Type: Perp	Initial Pass/Fail: Pass	Overall Compliance: No
Severity Score: 9			
Codes/Mitigation Info/Possible Solution		Field Measurements/Component Compliance

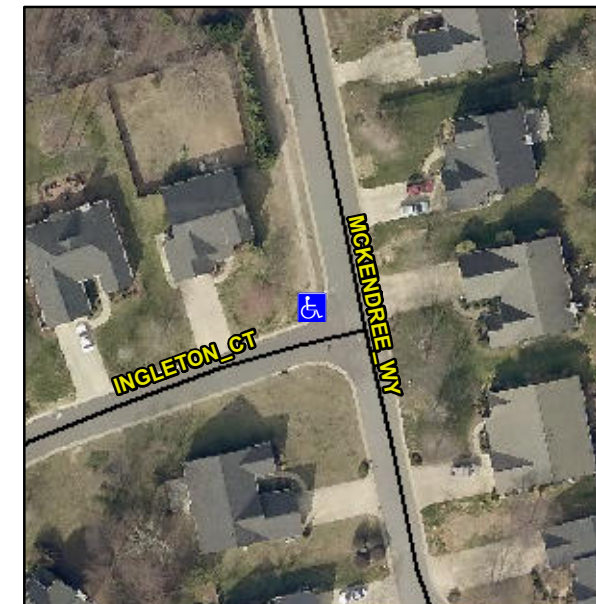
Compliance	Description	Data	Compliance	Description	Data
N/A	Ramp Length (in)	49.0	Yes	Ramp Slope (%)	5.3
Yes	Ramp Width (in)	48.0	Yes	Ramp XSlope (%)	1.7
N/A	Flare Type LT	Sloped	N/A	Flare Type RT	N/A
N/A	Flare Slope LT (%)	5.0	N/A	Flare Slope RT (%)	2.4
N/A	Flare Traversable LT?	No	N/A	Flare Traversable RT?	No
No	Landing Length (in)	46.0	Yes	DWS Provided?	Yes
No	Landing Width (in)	41.0	Yes	DWS Contrast?	Yes
Yes	Landing Slope (%)	0.3	Yes	DWS Length (in)	25.5
Yes	Landing X Slope (%)	1.8	Yes	DWS Full Width?	Yes
N/A	Landing Curb? (Y/N)	No	No	DWS Offset (in)	3.0
N/A	Shared Landing?	No			
Yes	Gutter Ponding?	No	No	Gutter Slope (%)	5.7
Yes	Gutter Lip Ht (in)	0.0	Yes	Gutter X Slope (%)	2.0
N/A	Painted X Walk1?	No	N/A	Painted X Walk2?	N/A
	X Walk 1 Direction	To S		X Walk 2 Direction	N/A
N/A	X Walk 1 Width (in)	N/A	N/A	X Walk 2 Width (in)	N/A
	X Walk 1 Slope (%)	5.0		X Walk 2 Slope (%)	N/A
	X Walk 1 X Slope (%)	3.7		X Walk 2 X Slope (%)	N/A

N/A	Ramp inside XWalk1?	N/A	N/A	Ramp inside XWalk2?	N/A
	Road Slope (%)	N/A	N/A	Clear Space?	Yes
	Road X Slope (%)	N/A	N/A	Clear Space to XWalk (in)	N/A
Yes	Any Obstructions?	No	Yes	Storm Grate/Utility Hazard?	No
	Obstruction Type			Storm Grate/Utility Type	
			N/A		N/A
			Yes	Surface Condition? (G/P)	Good

Possible Solutions:

**Remove & Replace Entire Ramp.
Remove & Replace Gutter.**

**Not Found, R304.2.1, R305.2,
R304.5.4**

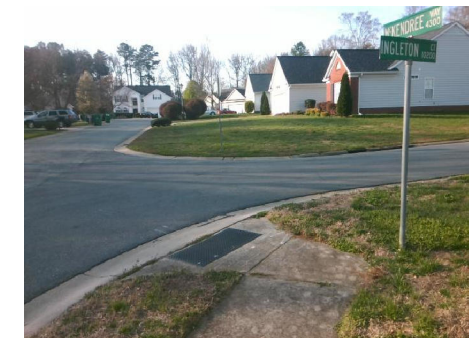
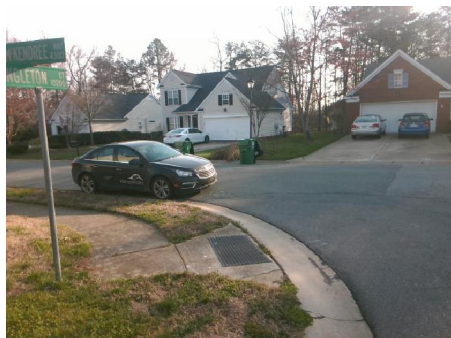
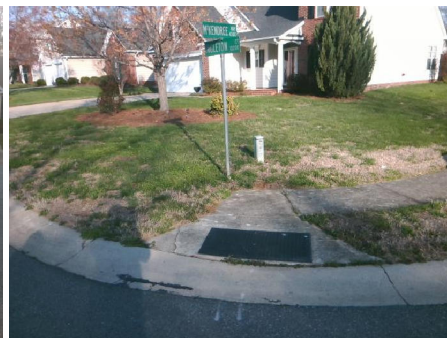
Street 1 Name **INGLETON CT**
 Stop Condition-Street 2 **StopSign**
 Street 2 Name **N/A**
 Stop Condition-Street 1 **N/A**
