Access Compliance Report

Public Rights-of-Way

(Curb Ramps)

Intersection ID: 10962	Main Street: NC_MUSIC_FACTORY_BV	Cross Street: MAXWELL_CT	Location: E
ADA ID: 40BBB70A51A2	Ramp Type: Directional1	Initial Pass/Fail: Fail	Overall Compliance: No
Codes/Mitigation Info/Possible Solution		Field Measurements/Component Compliance	
Severity Score: 13.75

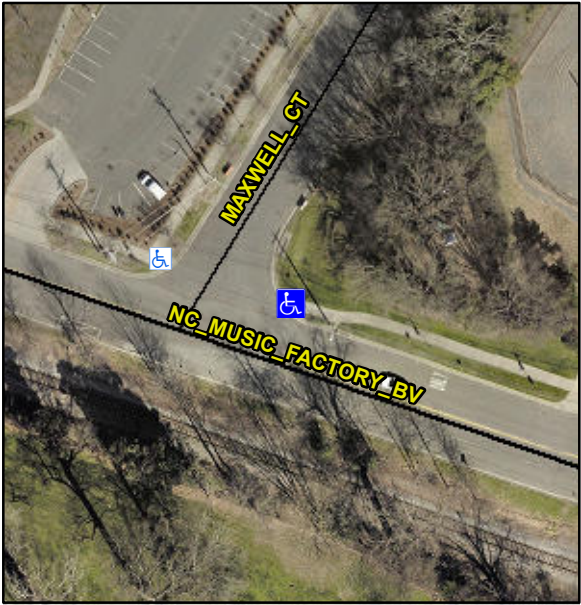
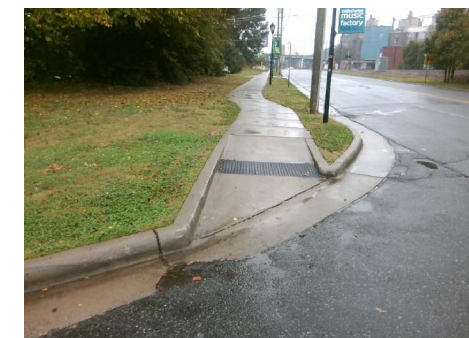
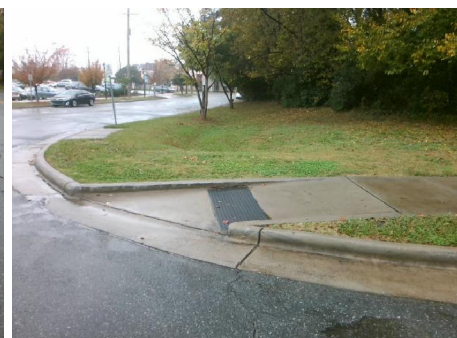
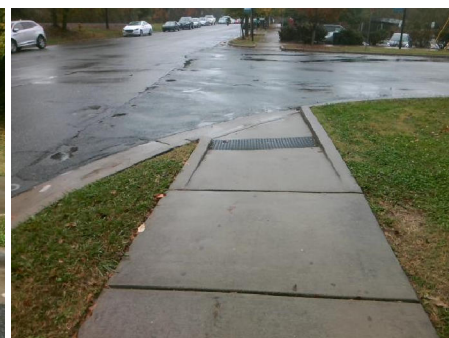
Possible Solutions:				
	Remove & Replace Entire Ramp.				
	Surveyor Notes:				
	N/A				
	PROW/ADA:				
	R304.2.2, R304.5.3				
	Street 1 Name	MAXWELL CT			
	Stop Condition-Street 1	StopSign			
	Street 2 Name	N/A			
	Stop Condition-Street 2	N/A			
Total Cost:		\$	1600.00		
		Compliance	Description	Data	Compliance Description Data
		N/A	Ramp Length (in)	91.0	N/A Grade Break? N/A
		Yes	Ramp Width (in)	59.0	N/A Grade Break Slope (%) 0.0
		No	Ramp Slope (%)	10.9	N/A Grade Break XSlope (%) 0.0
		No	Ramp XSlope (%)	2.9	
		N/A	Flare Type LT	N/A	N/A Flare Type RT N/A
		N/A	Flare Slope LT (%)	N/A	N/A Flare Slope RT (%) 0.0
		N/A	Flare Traversable LT?	N/A	N/A Flare Traversable RT? N/A
		N/A	Landing Length (in)	0.0	N/A DWS Provided? N/A
		N/A	Landing Width (in)	0.0	N/A DWS Contrast? N/A
		N/A	Landing Slope (%)	0.0	N/A DWS Length (in) N/A
		N/A	Landing X Slope (%)	0.0	N/A DWS Full Width? N/A
		N/A	Landing Curb? (Y/N)	N/A	N/A DWS Offset LT (in) N/A

N/A	Shared Landing?	N/A	N/A DWS Offset RT (in) N/A
		N/A	Gutter Ponding?	0.0	N/A Gutter Slope (%) N/A
		N/A	Gutter Lip Ht (in)	0.0	N/A Gutter X Slope (%) N/A
		N/A	Painted X Walk1?	No	Road Slope (%) 2.4
			X Walk 1 Direction	To W	Road X Slope (%) 2.7
			X Walk 1 Width (in)	N/A	Clear Space? N/A
			X Walk 1 Slope (%)	2.4	N/A Clear Space to XWalk (in) N/A
			X Walk 1 X Slope (%)	2.7	N/A Storm Grate/Utility Hazard? N/A
		N/A	Ramp inside XWalk1?	N/A	Storm Grate/Utility Type
		N/A	Any Obstructions?	N/A	N/A
			Obstruction Type		Yes Surface Condition? (G/P) Good
				N/A	N/A Curb Slope (%) 10.6
