Access Compliance Report Public Rights-of-Way (Curb Ramps)

Intersection ID: 16392 Main Street: QUEENS RD WEST **Cross Street: WELLESLEY AV** Location: NW ADA ID: 40C6672AE378 Ramp Type: Perp Initial Pass/Fail: Fail **Overall Compliance: No Severity Score:** 12.5

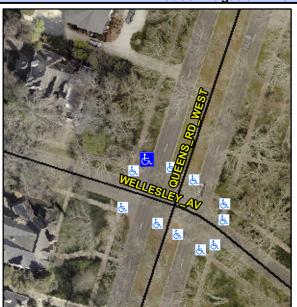
001111	manec Description	Dutu	Compliance Description		Dutu
N/A	Ramp Length (in)	52.0	No	Ramp Slope (%)	8.9
Yes	Ramp Width (in)	63.0	Yes	Ramp XSlope (%)	1.6
N/A	Flare Type LT	N/A	N/A	Flare Type RT	N/A
N/A	Flare Slope LT (%)	N/A	N/A	Flare Slope RT (%)	N/A
N/A	Flare Traversable LT?	N/A	N/A	Flare Traversable RT?	N/A
N/A	Landing Length (in)	N/A	N/A	DWS Provided?	N/A
N/A	Landing Width (in)	N/A	N/A	DWS Contrast?	N/A
N/A	Landing Slope (%)	N/A	N/A	DWS Length (in)	N/A
N/A	Landing X Slope (%)	N/A	N/A	DWS Full Width?	N/A
N/A	Landing Curb? (Y/N)	N/A	N/A	DWS Offset (in)	N/A
N/A	Shared Landing?	N/A			
N/A	Gutter Ponding?	N/A	N/A	Gutter Slope (%)	N/A
N/A	Gutter Lip Ht (in)	N/A	N/A	Gutter X Slope (%)	N/A
N/A	Painted X Walk1?	No	N/A	Painted X Walk2?	N/A
	X Walk 1 Direction	To SE		X Walk 2 Direction	N/A
N/A	X Walk 1 Width (in)	N/A	N/A	X Walk 2 Width (in)	N/A
	X Walk 1 Slope (%)	3.6		X Walk 2 Slope (%)	N/A
	X Walk 1 X Slope (%)	1.8		X Walk 2 X Slope (%)	N/A

N/A	Ramp inside XWalk1?	N/A	N/A	Ramp inside XWalk2?	N/A
	Road Slope (%)	N/A	N/A	Clear Space?	N/A
	Road X Slope (%)	N/A	N/A	Clear Space to XWalk (in)	N/A
N/A	Any Obstructions?	N/A	N/A	Storm Grate/Utility Hazard?	N/A
	Obstruction Type			Storm Grate/Utility Type	
		N/A			N/A
			Yes	Surface Condition? (G/P)	Good

Possible Solutions:				
C	Remove & Replace Entire Ramp.				
A STATE OF THE PARTY OF THE PAR					
100	Curvoyar Notes				
	Surveyor Notes:				
のことの一種の名	N/A				
28.0	PROW/ADA:				
The state of the s	R304.2.2

Total Cost: 1850.00
