Access Compliance Report

Public Rights-of-Way

(Curb Ramps)

Intersection ID: 47659	Main Street: FENWAY_DR	Cross Street: WRIGLEY_DR	Location: SE
ADA ID: 40D75DFFA16A	Ramp Type: PerpDiag	Initial Pass/Fail: Fail	Overall Compliance: No
			Severity Score: 21.25

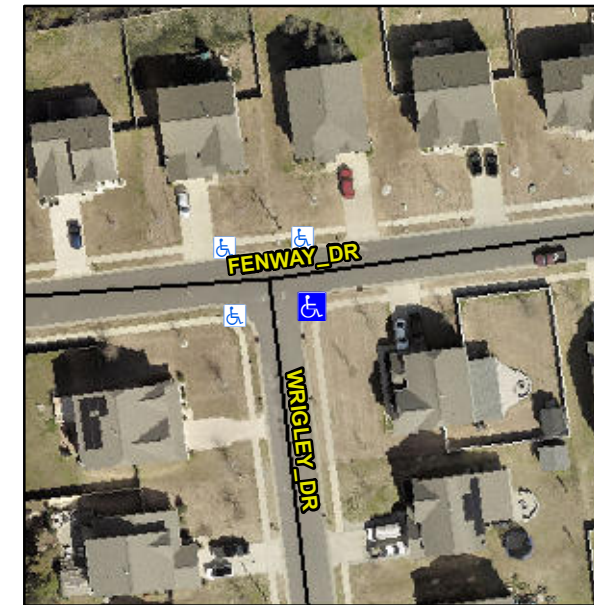
Compliance	Description	Data	Compliance	Description	Data
N/A	Ramp Length (in)	47.0	Yes	Ramp Slope (%)	5.5
No	Ramp Width (in)	47.5	No	Ramp XSlope (%)	6.8
N/A	Flare Type LT	N/A	N/A	Flare Type RT	N/A
N/A	Flare Slope LT (%)	N/A	N/A	Flare Slope RT (%)	N/A
N/A	Flare Traversable LT?	N/A	N/A	Flare Traversable RT?	N/A
N/A	Landing Length (in)	N/A	N/A	DWS Provided?	N/A
N/A	Landing Width (in)	N/A	N/A	DWS Contrast?	N/A
N/A	Landing Slope (%)	N/A	N/A	DWS Length (in)	N/A
N/A	Landing X Slope (%)	N/A	N/A	DWS Full Width?	N/A
N/A	Landing Curb? (Y/N)	N/A	N/A	DWS Offset (in)	N/A
N/A	Shared Landing?	N/A			
N/A	Gutter Ponding?	N/A	N/A	Gutter Slope (%)	N/A
N/A	Gutter Lip Ht (in)	N/A	N/A	Gutter X Slope (%)	N/A
N/A	Painted X Walk1?	No	N/A	Painted X Walk2?	No
	X Walk 1 Direction	To N		X Walk 2 Direction	To W
N/A	X Walk 1 Width (in)	N/A	N/A	X Walk 2 Width (in)	N/A
	X Walk 1 Slope (%)	3.0		X Walk 2 Slope (%)	1.4
	X Walk 1 X Slope (%)	2.1		X Walk 2 X Slope (%)	3.1

N/A	Ramp inside XWalk1?	N/A	N/A	Ramp inside XWalk2?	N/A
	Road Slope (%)	5.1	N/A	Clear Space?	N/A
	Road X Slope (%)	2.5	N/A	Clear Space to XWalk (in)	N/A
N/A	Any Obstructions?	N/A	N/A	Storm Grate/Utility Hazard?	N/A
	Obstruction Type			Storm Grate/Utility Type	
		N/A			N/A
			Yes	Surface Condition? (G/P)	Good

Remove & Replace Curb Ramp With Two New Directional Ramps or Equivalent.

R304.5.1, R304.5.3
